RE: In the Matter of Otter Tail Power Company 2014 Annual Safety, Reliability and Service Quality Report and Proposed SAIFI, SAIDI and CAIDI Reliability Standards for 2015
Docket No. E017/M-15-___

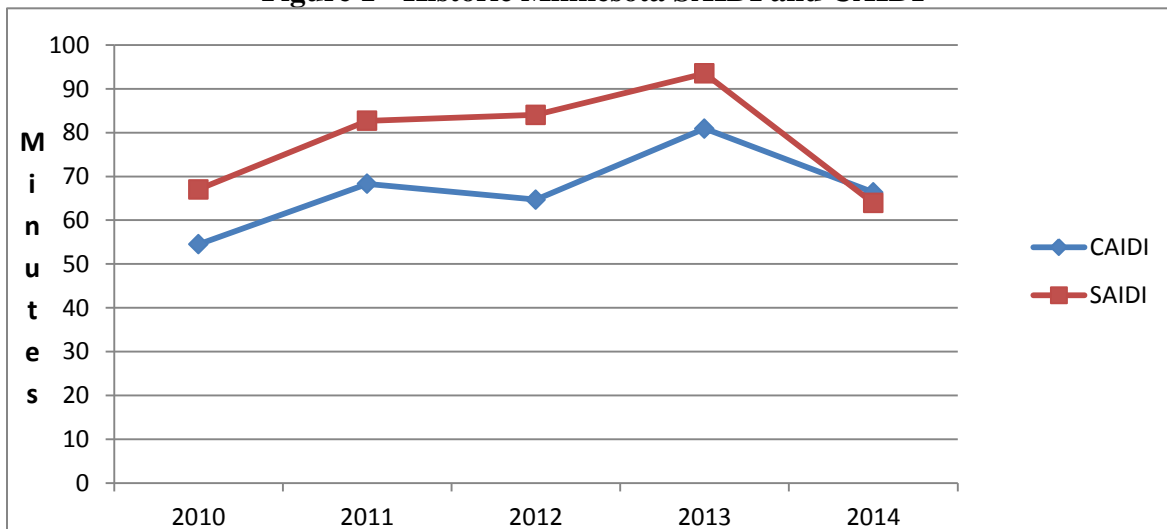
Figure 1 - Historic Minnesota SAIDI and CAIDI

Otter Tail Power MN Customers saw improvement in SAIDI and CAIDI for 2014 when compared to 2013 results.

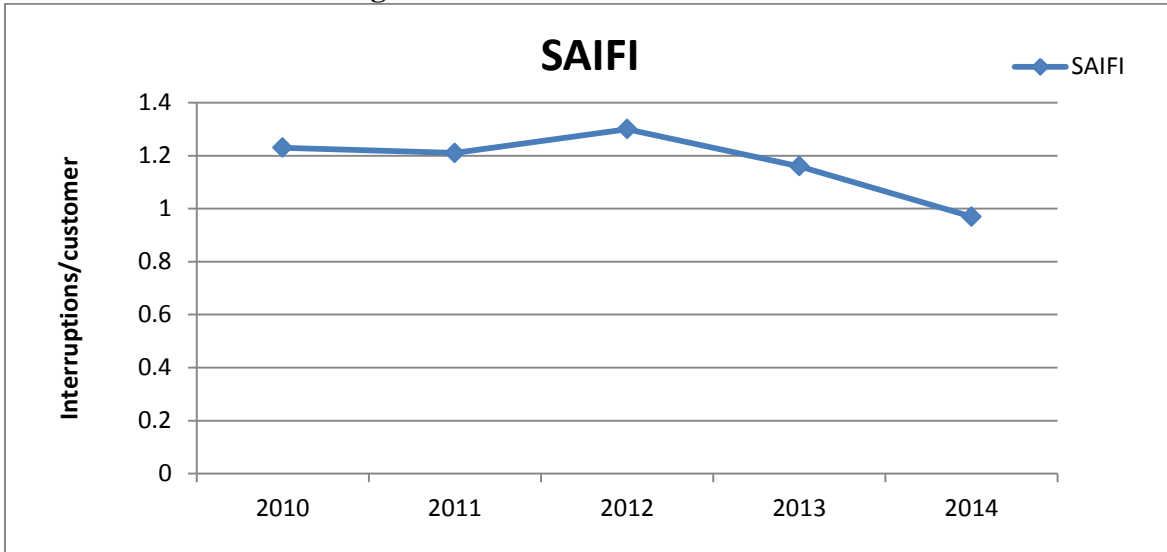
Figure 2 - Minnesota Historic SAIFI

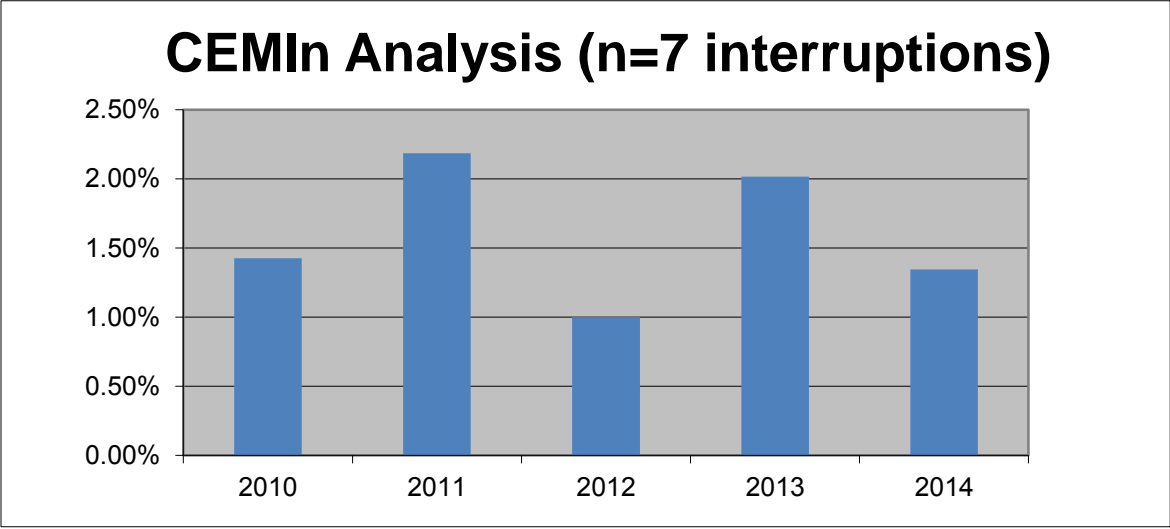
Figure 8

- 4. **Measuring reliability:** Otter Tail continues to calculate the Customers Experiencing Multiple Interruptions (CEMIn) index. The CEMIn index is an excellent indicator of how system improvements directly affect customer service. Deployment of resources on worst performing circuits has direct effects on the reliability indices and customer reliability. **Figure 8** shows the CEMIn results from 2010 to 2014. This graph shows how many customers on a company-wide basis experienced seven or more interruptions. For example in 2014 the percentage of customers experiencing seven or more interruptions was 1.3 percent, compared to 2013, which was 2 percent.

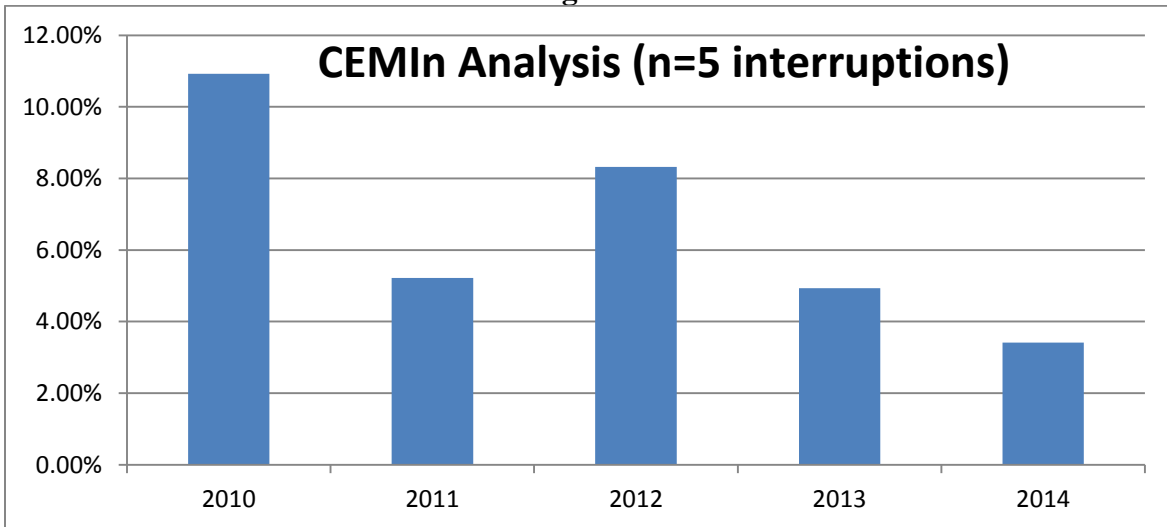
Figure 9

In 2012, Otter Tail began to track and analyze CEMI5 data. We believe the threshold of five allows us to better identify and consider actions to be taken to improve performance of transmission and distribution line sections. **Figure 9** below shows the percentage of customers on a company-wide basis who have experienced five or more sustained interruptions.

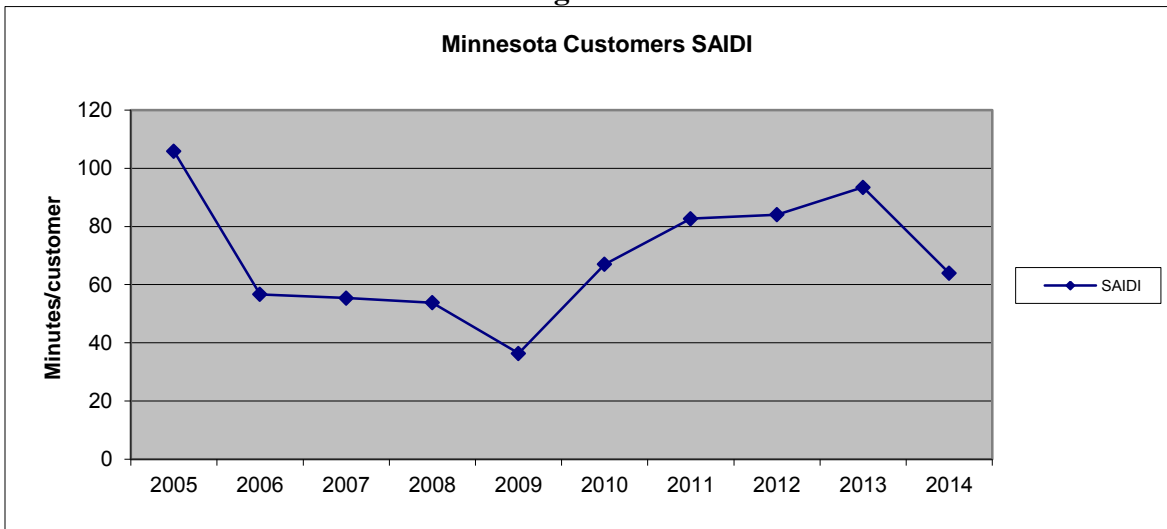
Figure 10

Figures 10, 11, and 12. The following graphs show Otter Tail’s SAIDI, SAIFI and CAIDI for the period of 2005 through 2014. When compared to 2013 results, Minnesota customers experienced a decrease in overall SAIDI, SAIFI and CAIDI. Minnesota SAIDI is the lowest it has been since 2010. SAIFI continues to trend downward. CAIDI results show an 18 percent improvement over 2013.
