**RE: In the Matter of Otter Tail Power Company 2020 Annual Safety, Reliability and Service Quality Report and Proposed SAIFI, SAIDI and CAIDI Reliability Standards for 2021
Docket No. E017/M-21-**

Safety, Reliability, and Service Quality Report for 2020

Proposed SAIFI, SAIDI, and CAIDI
Reliability Standards for 2021
Including Additional Compliance Obligations

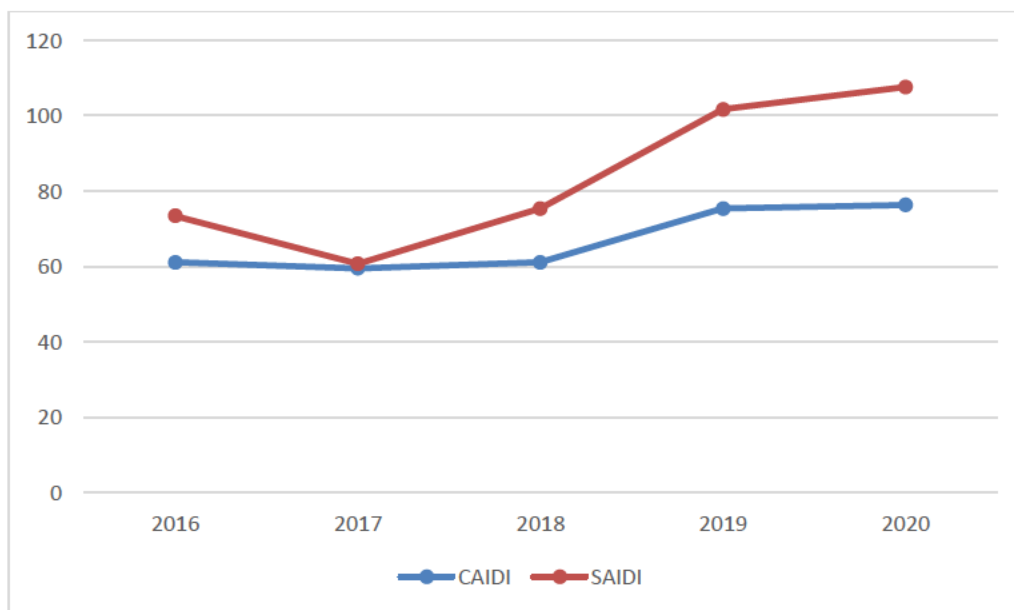
Figure 1 - Historic Minnesota SAIDI and CAIDI

Otter Tail saw performance levels increase for SAIDI and a slight increase for CAIDI for 2020 compared to 2019 results.

As included in previous reports, Otter Tail provides a summary table that allows the reader to more easily assess the overall reliability of the system and identify the main factors that affect reliability. Figure 1 through Figure 5 below provides a summary of Otter Tail's overall reliability and service quality for the years 2016 through 2020. It should also be noted that Otter Tail moved from an outdated/obsolete reporting system to a new Interruption Monitoring System (IMS) in 2019. With this change, more granular SAIDI, CAIDI, and SAIFI information is captured. Thus, comparison of 2019 data to historical data should not be considered like for like.

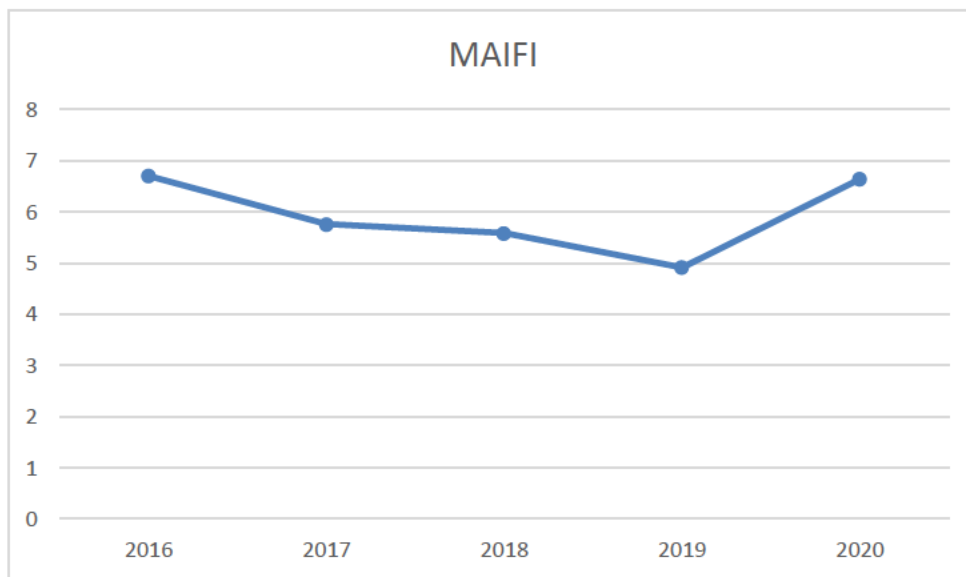
Figure 3 – Minnesota Historic MAIFI

MAIFI is the momentary average interruption frequency index. It is an indication of the average number of momentary interruptions the average customer received over the course of a year, for a particular region. Otter Tail views MAIFI as a leading indicator for future SAIDI and thus tracks and analyzes line sections with excessive momentary interruptions for future capital improvements or possible vegetation management needs. Overall, Otter Tail saw an increase in 2020 results when compared to 2019.

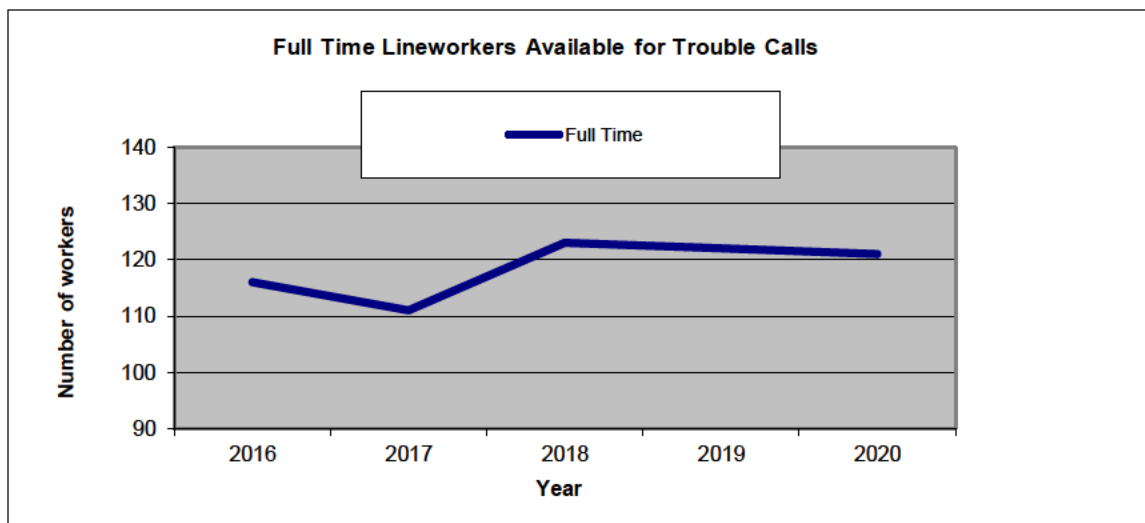
Figure 4 – Full Time Lineworkers available for trouble calls and for the operation and maintenance of Minnesota distribution lines

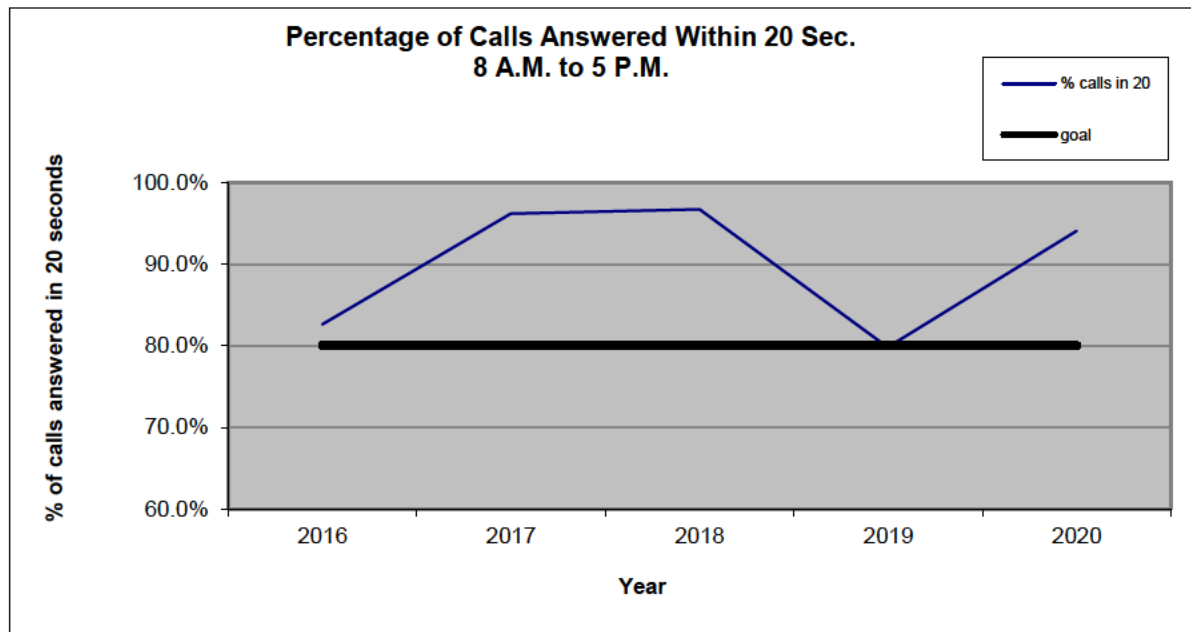
Figure 5 - Calls Answered within 20 Seconds

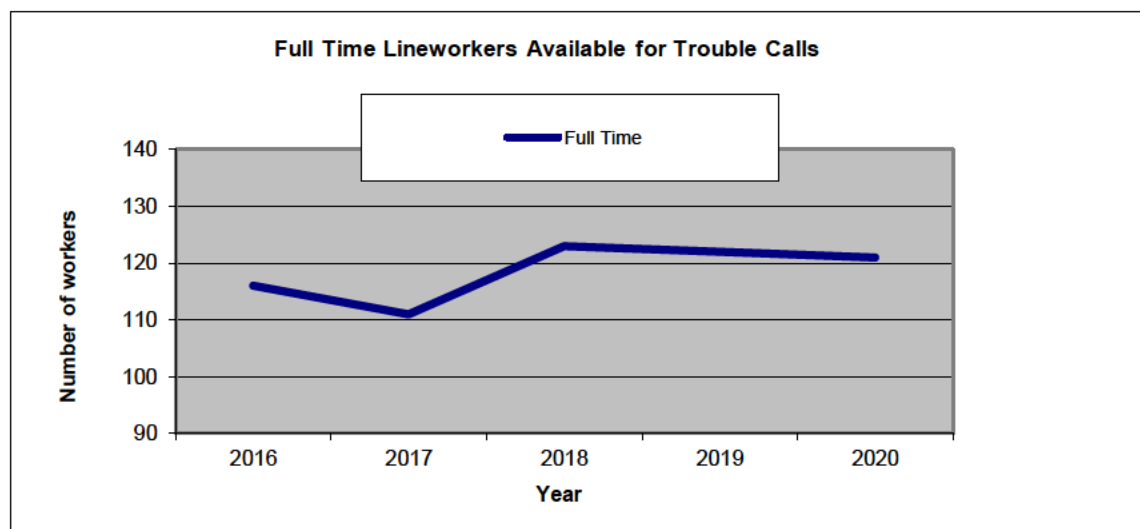
Figure 6 below depicts by year the number of full-time line workers available for trouble and for the operation and maintenance of distribution lines. Otter Tail also has a reliability engineer who supports system reliability related functions. This individual is not included in the above staffing level information. Additionally, Otter Tail has engineers in its Asset Management area who, due to the nature of their roles, support reliability on a daily, weekly, monthly, and annual basis.

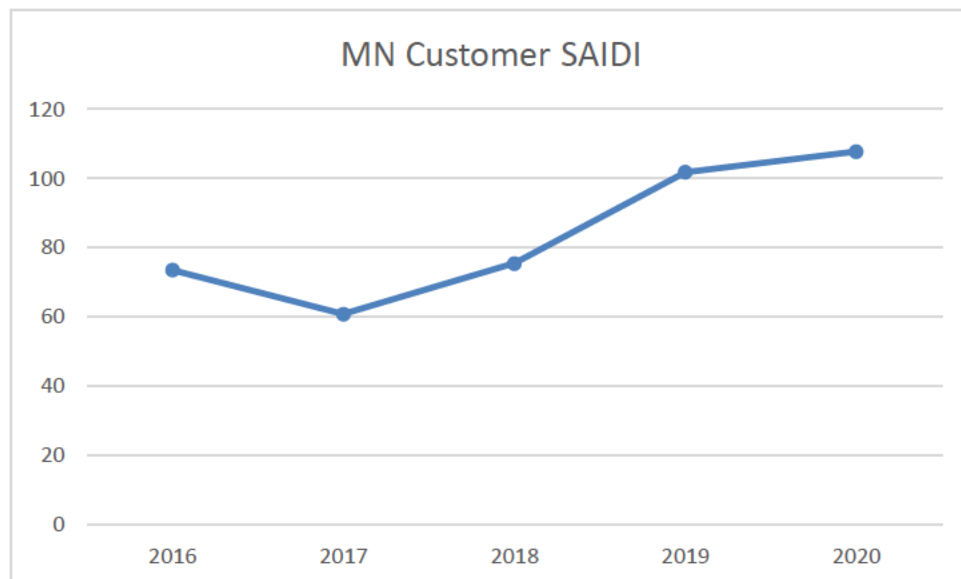
Figure 7

Figures 7, 8, and 9. The following graphs show Otter Tail’s SAIDI, SAIFI and CAIDI for the period of 2016 through 2020. When compared to 2018 results, Minnesota customers experienced an increase in overall SAIDI, SAIFI, and CAIDI.

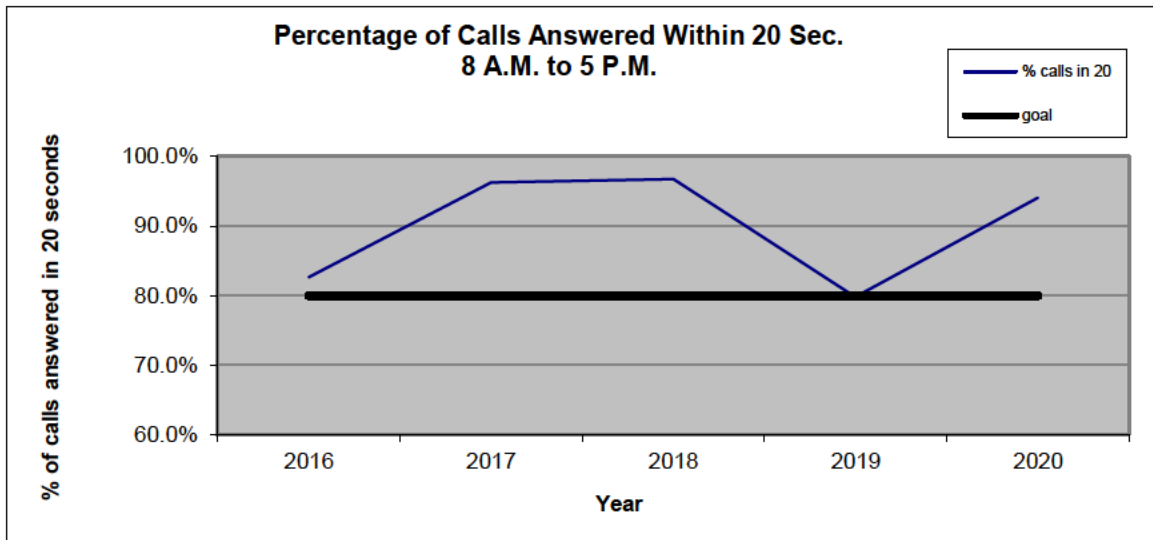
Figure 10

In compliance with this rule, Otter Tail provides its report of call center response times for 2020 in **Table 25**. **Figure 10** shows a historical graph showing the percent of Minnesota calls answered within 20 seconds.

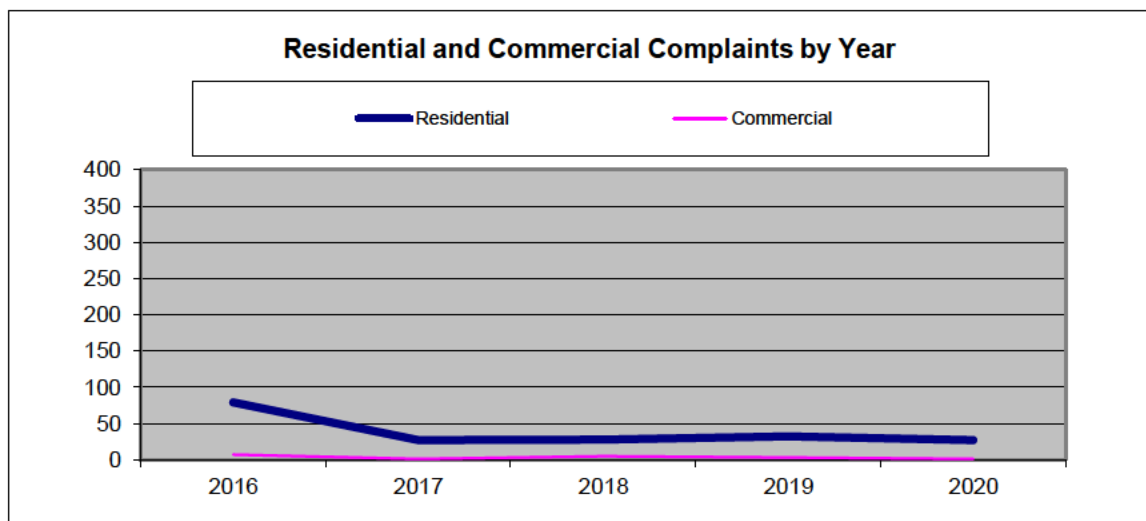
Figure 11 below is a graph showing complaints by customer class for the previous five years.

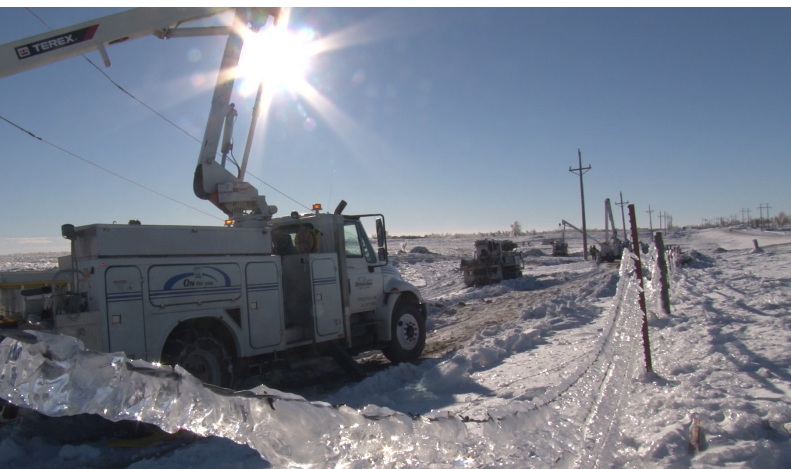
Two of the ways in which we measure our reliability are the average number of interruptions and average length of time our customers were without power.
