I.	Introduction and Qualifications	1
II.	Root Cause Investigation	3
	A. Background on Sherco Unit 3 Turbine-Generator Train	4
	B. The Event	6
	C. The Root Cause Analysis	9
III.	Determined Cause of Failure	10
IV.	Additional Observations and Opinions	17

Statement of Qualifications	Schedule 1
Root Cause Analysis Steam Turbine Generator Event of November 19, 2011	Schedule 2
Root Cause Analysis Report-Figures and Attachments	Schedule 3

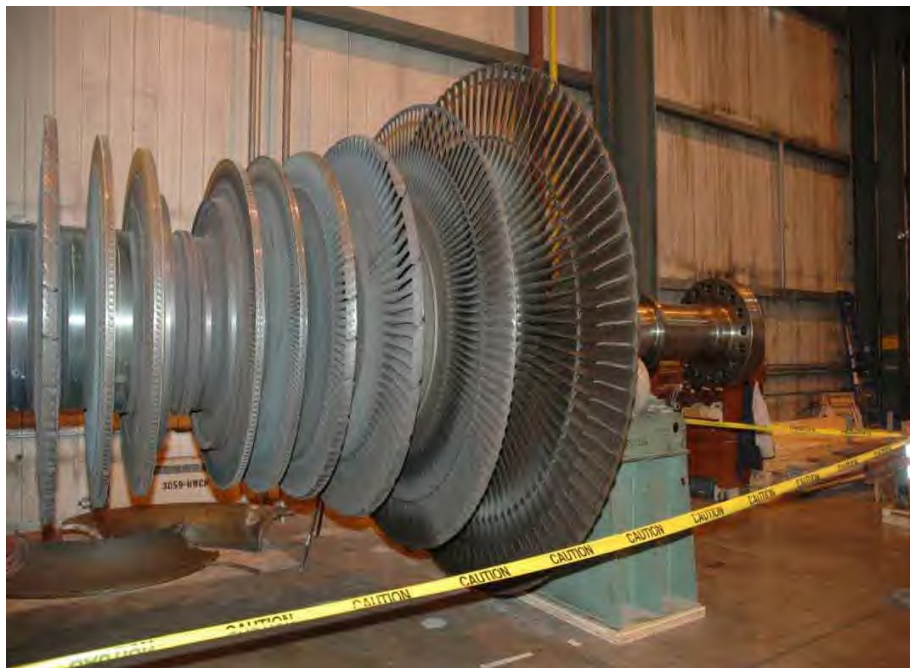
The Low Pressure Turbine "A" inner casing was opened and the rotor placed on stands at the plant for examination as shown in Figs. 44 to 47. The generator end blading exhibited light to moderate rub damage to all blade covers and tenons with the heaviest being on the L-3, L-4 and L-5 stages as shown in Figs. 48 and 49. The turbine end L-2, L-3, L-4 and L-5 blade covers and tenons exhibited moderate rub damage with the L-3 stage blading exhibiting a few bent and torn blade cover edges as shown in Figs. 50, 51 and 52. Light to moderate impact damage to blade leading and trailing edges was noted. Turbine and generator end diaphragm vanes exhibited moderate impact

Fig. 44. Photograph of low pressure turbine rotor "A" in stands at site.

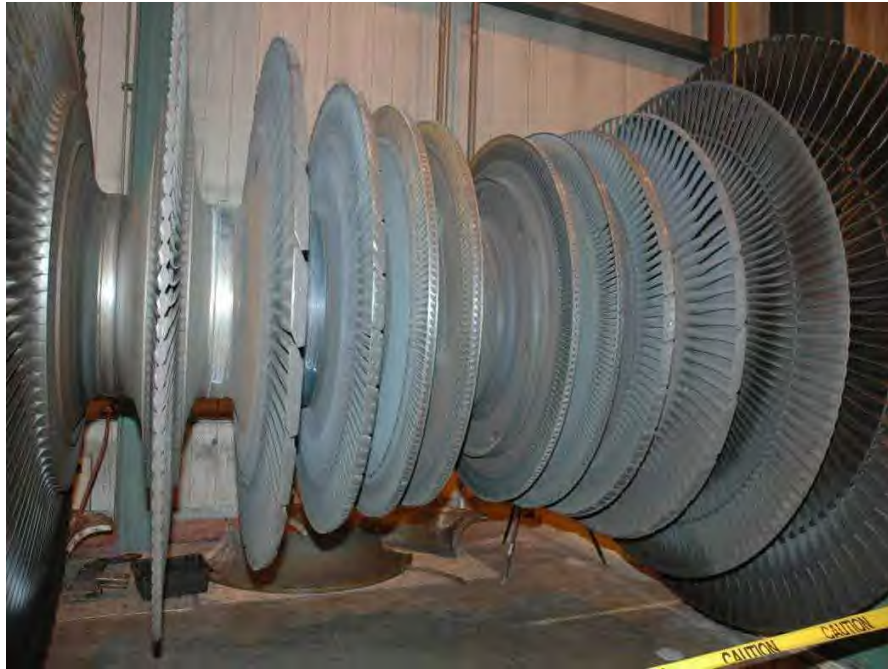
Fig. 45. Photograph of low pressure turbine rotor "A" shown in Fig. 44.

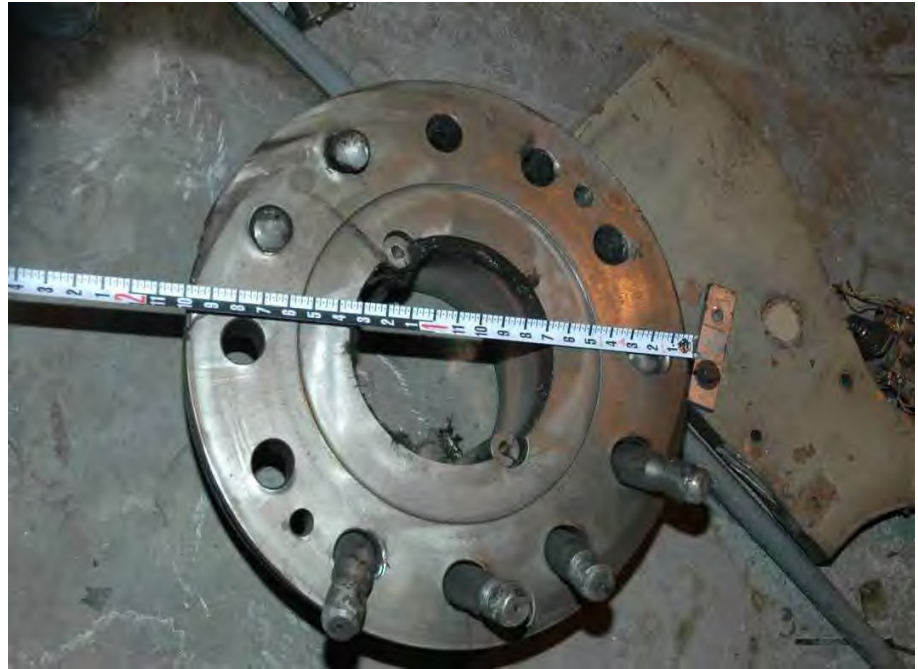
The generator shaft was found to be fractured transversely just forward of the generator collector ring as shown in Figs. 104 and 105. The generator shaft end coupling was liberated from the generator shaft during the event and found on the "doghouse" enclosure floor (Fig. 106). The exciter shaft fractured transversely at three locations, adjacent to the No. 11 bearing, adjacent to the No. 12 bearing and at the Alterex collector ring as shown in Figs. 107 to 109. The fracture at the end of the exciter shaft resulted in the liberation of the Alterex collector ring which burst through the "doghouse" enclosure and bounded across the turbine deck, through a meeting room and came to rest in the control room as shown in Fig. 110. The generator rotor and stator sustained extensive rub damage as shown in Figs. 111 to 114.

Fig. 106. Photograph of coupling from generator shaft end.

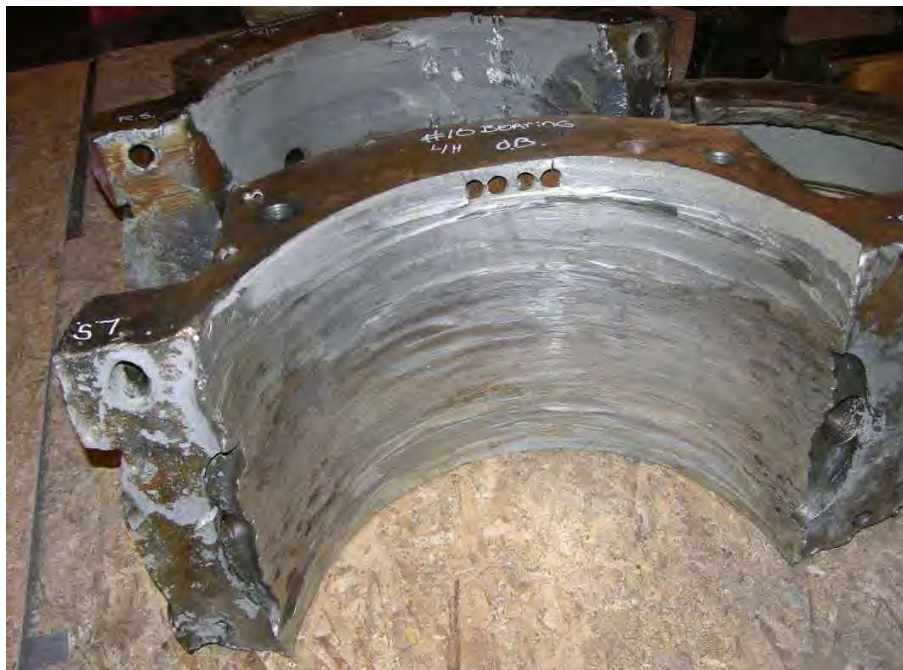
All bearings exhibited severe rub damage and transferred metal as shown in Figs. 115 to 118. Some bearings were liberated from the unit while others were found with the bottom half rolled into/under the top half.

Fig. 115. Photograph of No. 10 bearing.

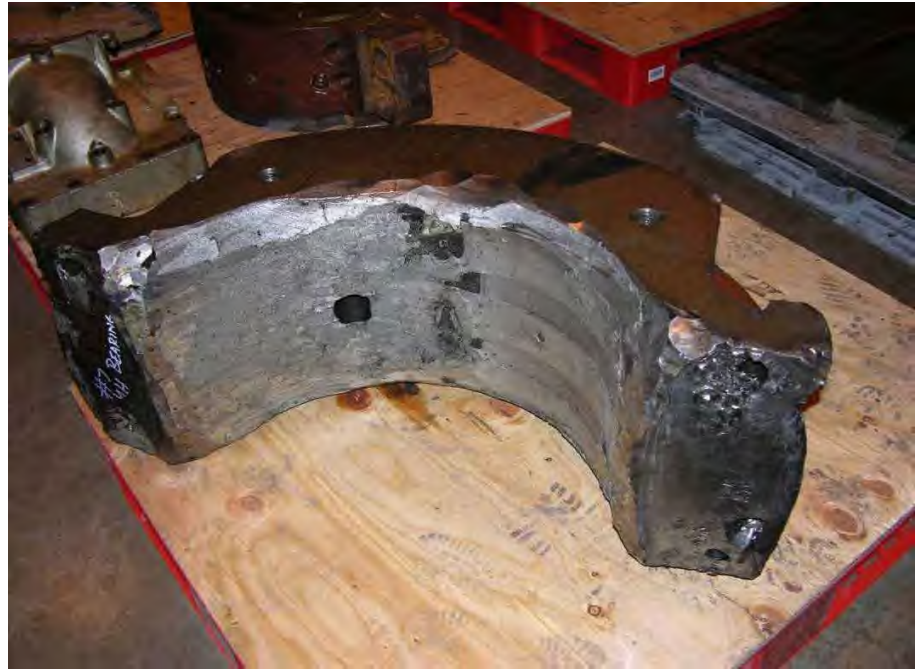
Fig. 116. Photograph of No. 7 bearing.

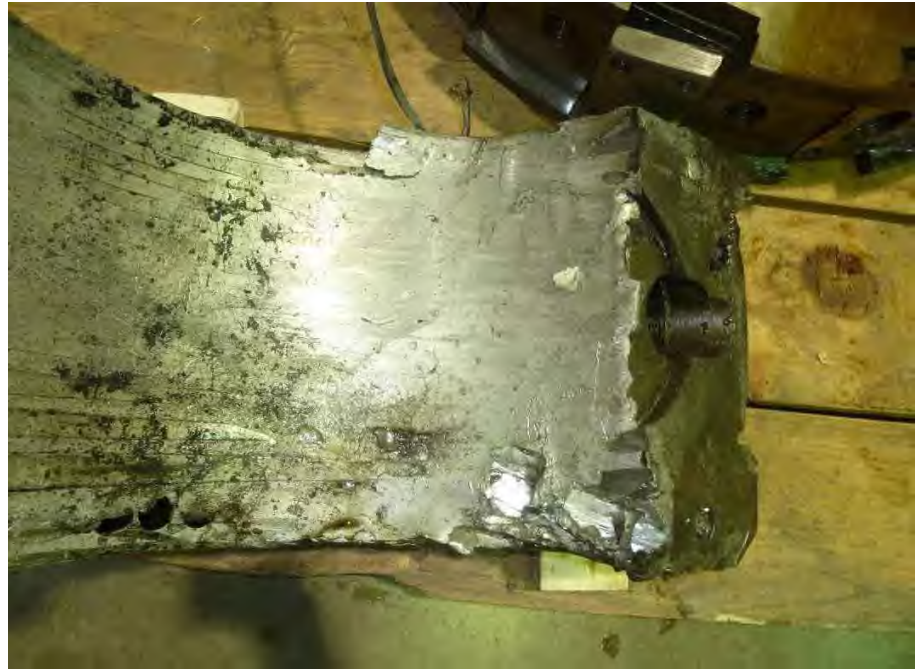
Fig. 118. Photograph of bearing from Unit 3 (bearing No. unknown).

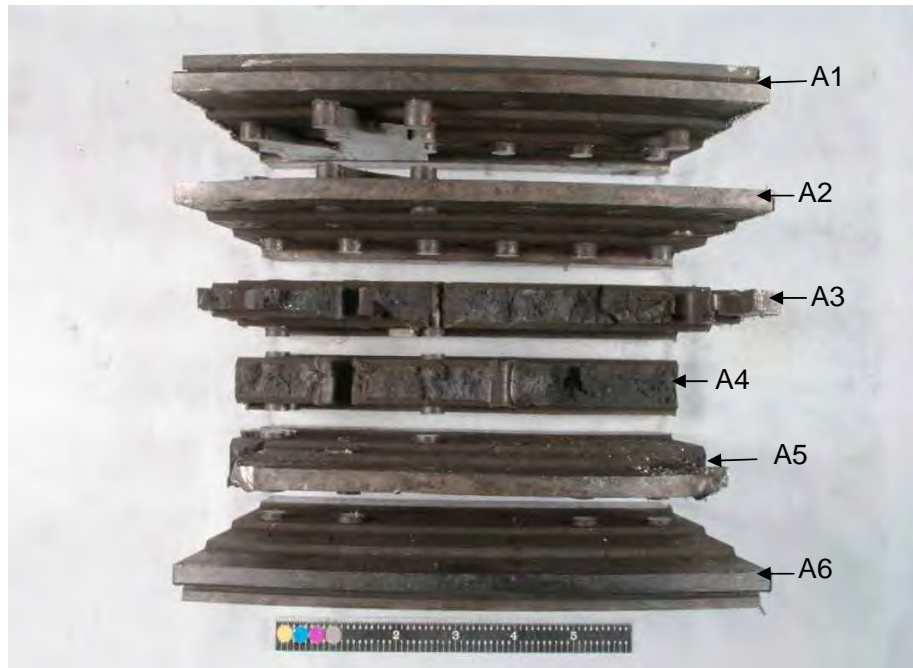
Subsegment "A" from SID 14874 was sectioned circumferentially between each finger pinned blade attachments and each finger was identified as "A1-A6" as shown in Fig. 125. The two middle finger pinned blade attachments in Subsegment "A" were fractured transversely. One finger root attachment fracture occurred at the ledge at the first section thickness change above the base of the attachment, extended to an adjacent pin hole and then extended diagonally outboard to the disk rim outer diameter (OD) as shown in Fig. 126. Fracture through the other finger pinned blade attachment occurred at the base of the attachment, extended radially outboard intersecting a pin hole then progressed circumferentially along the ledge at the first section thickness change above the base of the attachment and finally intersected another pin hole as shown in Fig. 127. All fracture surfaces examined exhibited coarse textured fracture morphology as shown in Figs. 128 to 135. Terminal portions of fractures exhibited morphology indicative of tensile/shear overload. No primary origin location(s) could be identified.

Fig. 125. SID 14874 subsegment "A" after circumferential sectioning.

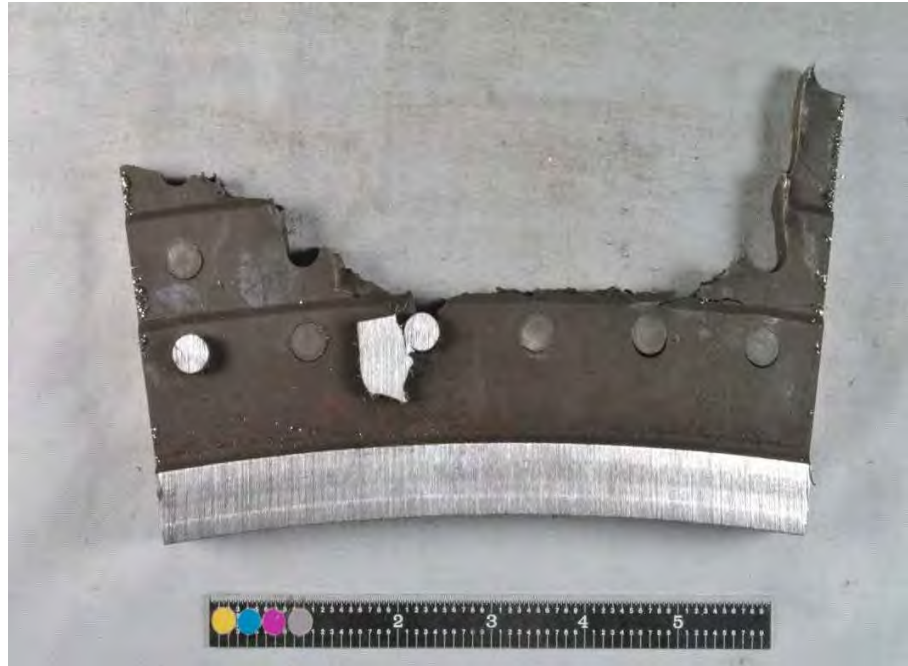
Fig. 126. SID 14874 subsegment "A3" finger pinned blade attachment.

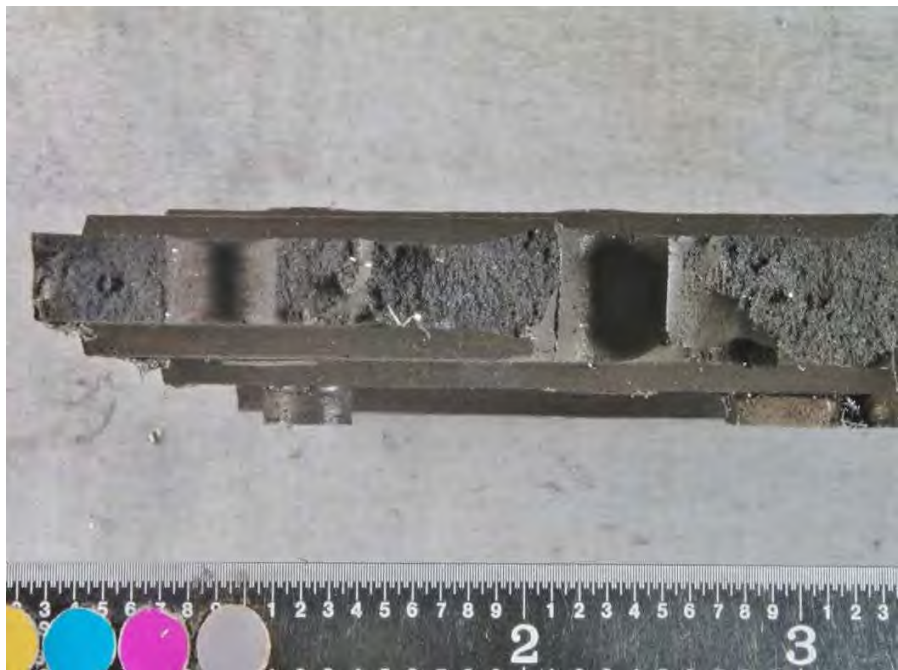
Fig. 129 Close-up of SID 14874 subsegment "A3" fracture surface shown in Fig. 128.

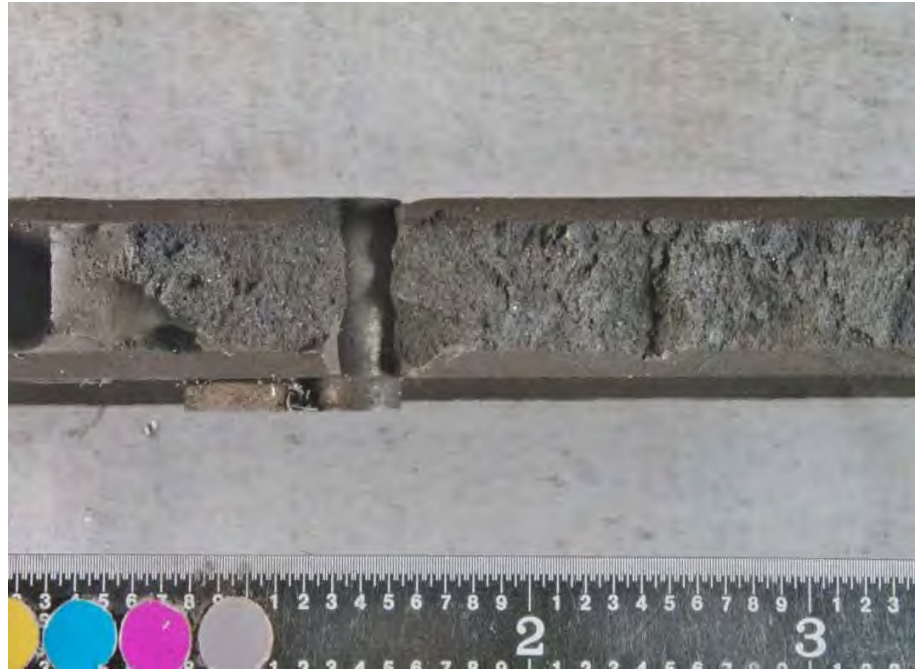
Fig. 130. Close-up of SID 14874 subsegment "A3" fracture surface shown in Fig. 128.

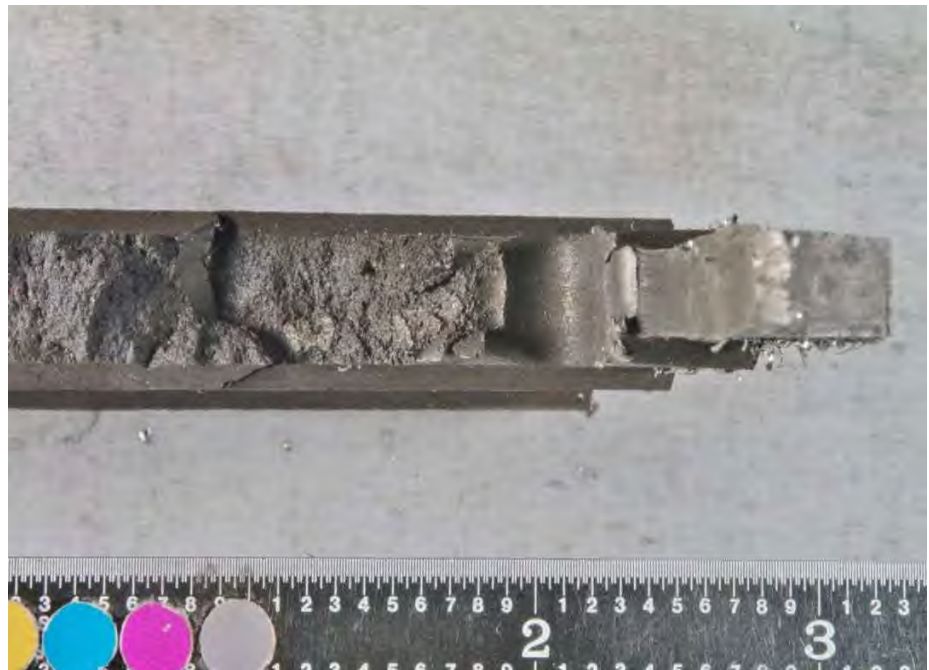
Fig. 131. Close-up of SID 14874 subsegment "A3" fracture surface shown in Fig. 128.

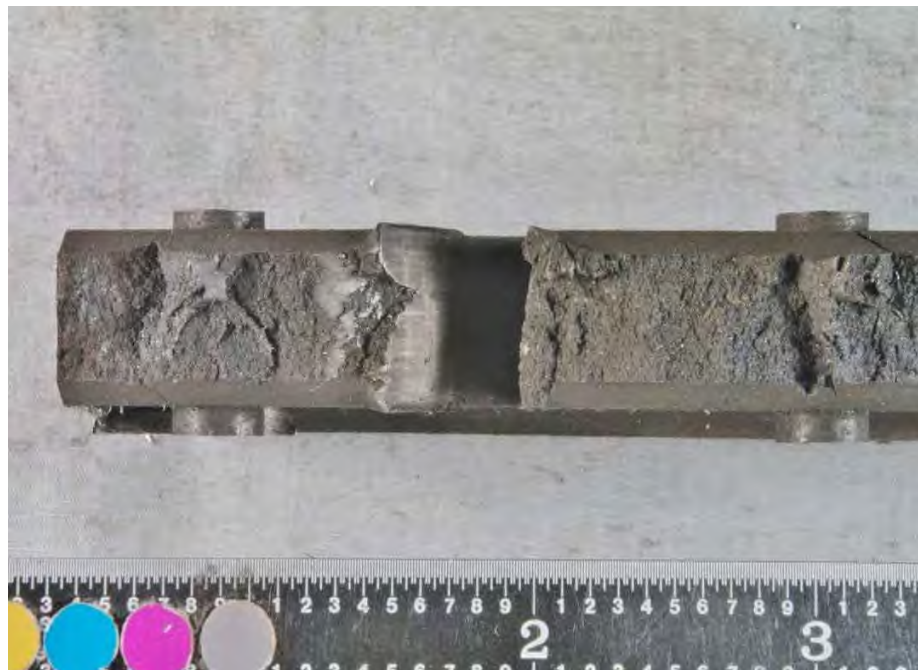
Fig 133. Close-up of SID 14874 subsegment "A4" fracture surface shown in Fig. 132.

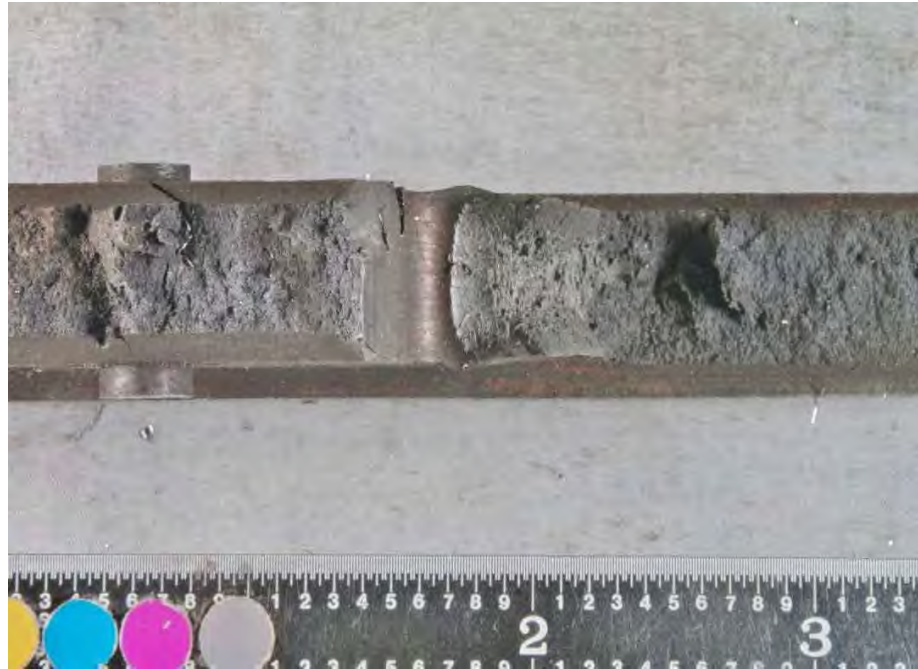
Fig. 134. Close-up photograph of SID 14874 subsegment "A4" fracture surface shown in Fig. 132.

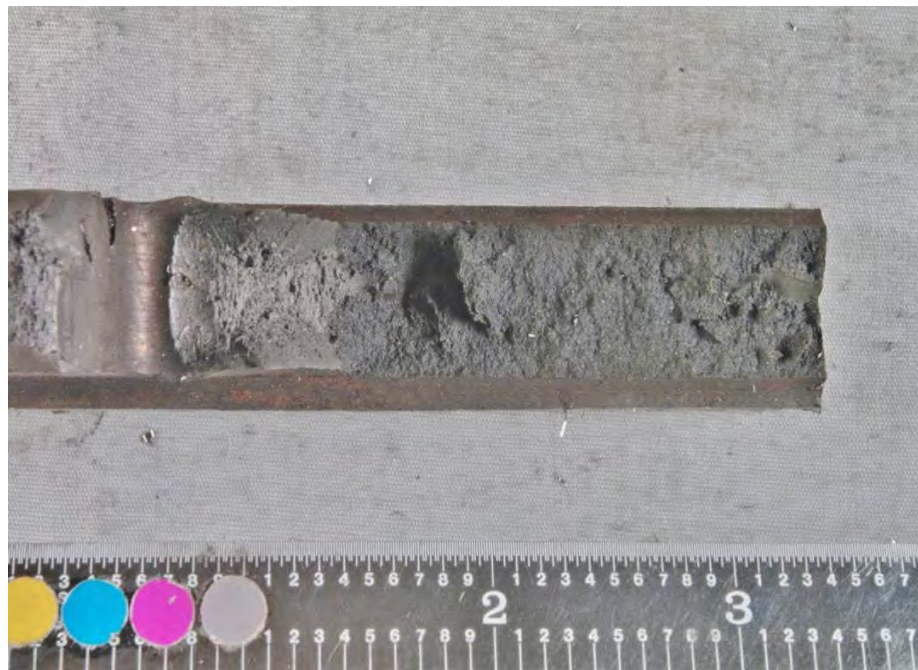
Fig. 135. Close-up photograph of SID 14874 subsegment "A4" fracture surface shown in Fig. 132.

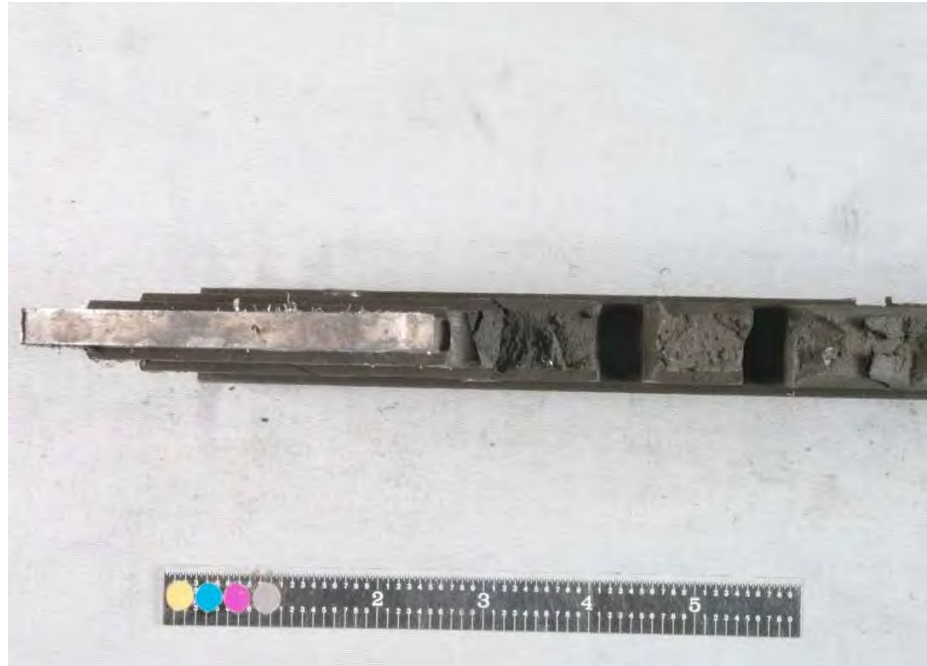
Fig. 140. Close-up of SID 14875 subsegment "B3" fracture surface.

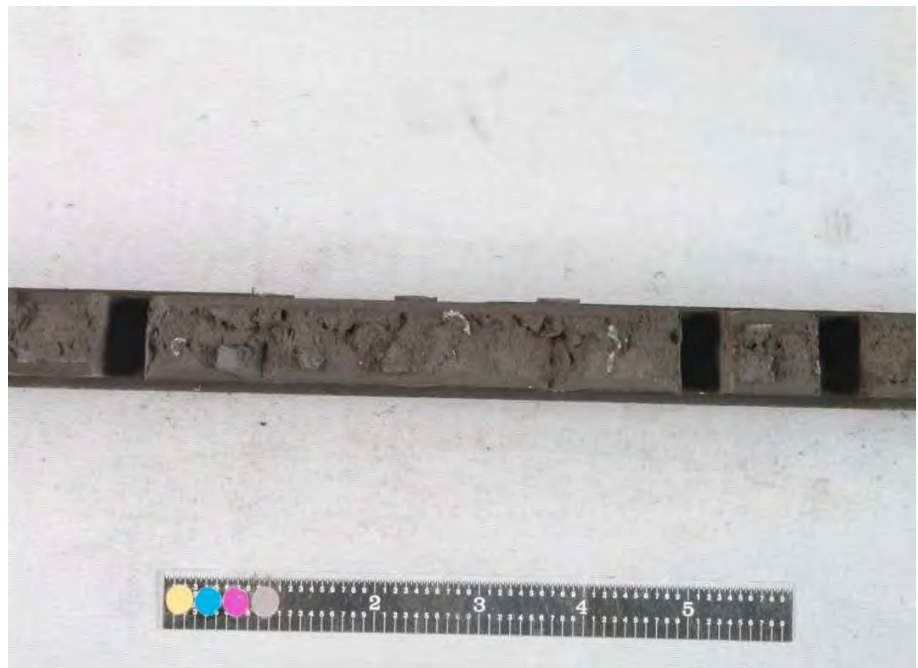
Fig. 141. Close-up of SID 14875 subsegment "B3" fracture surface.

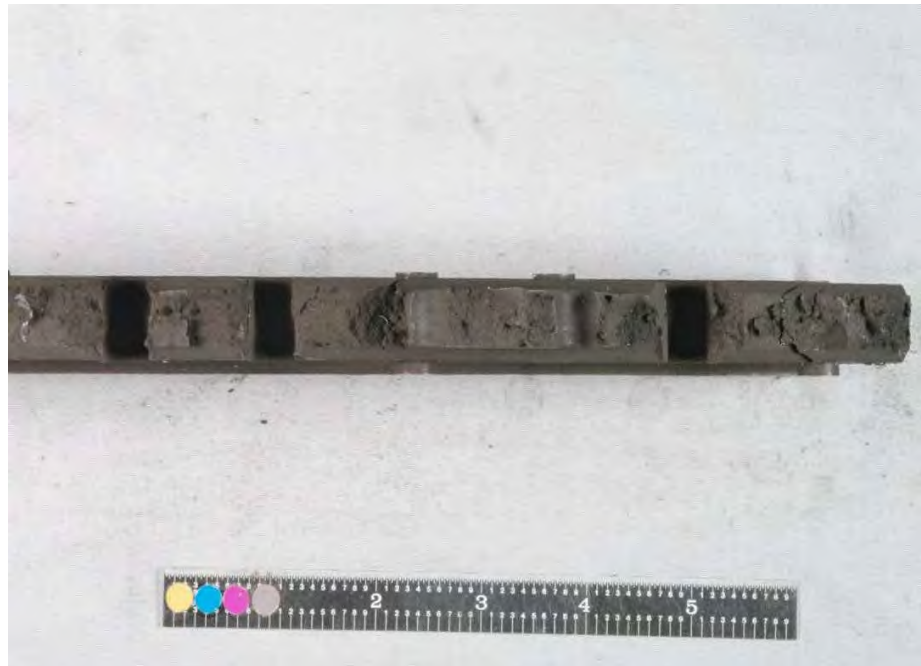
Fig. 142. Close-up of SID 14875 subsegment "B3" fracture surface.

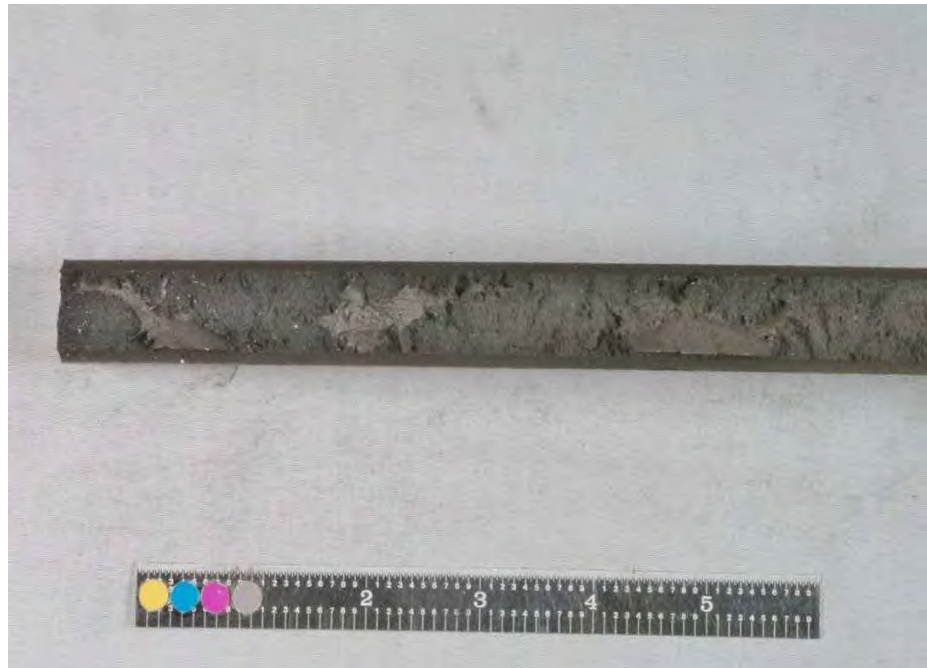
Fig 146. Close-up of SID 14875 subsegment "B4" fracture surface.

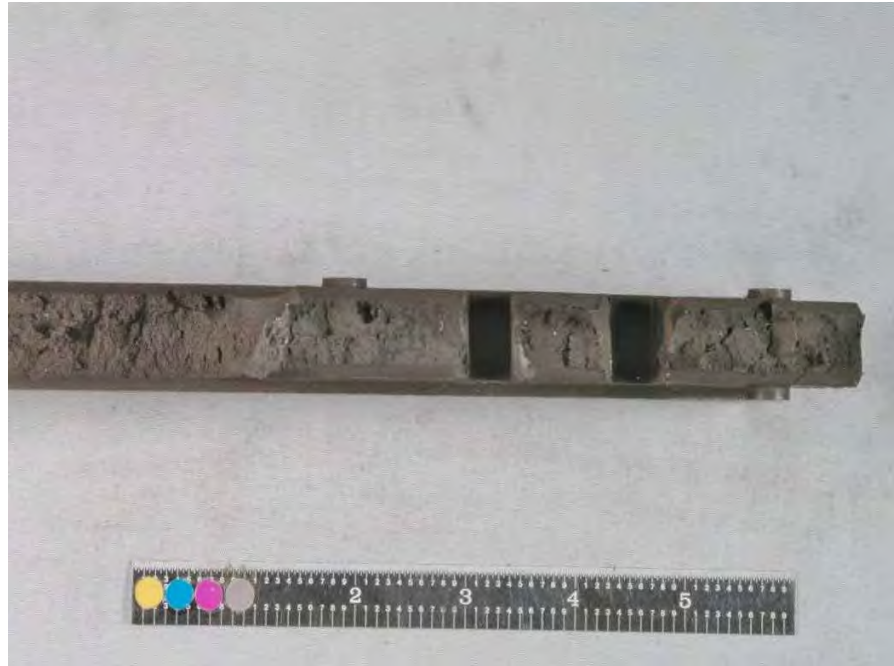
Fig. 148 Close-up of SID 14875 subsegment "B4" fracture surface.

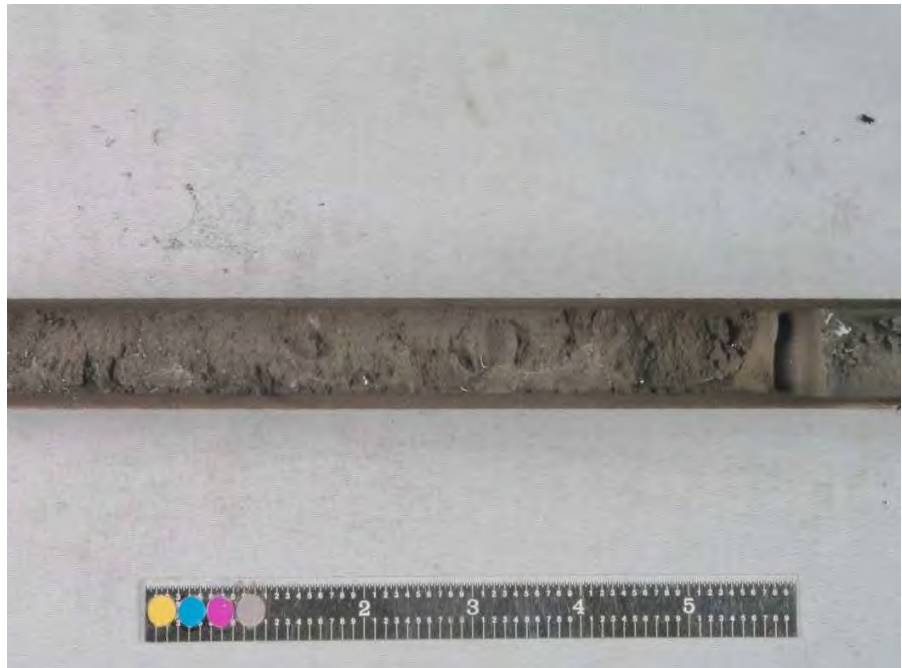
Fig. 150. Close-up of SID 14875 subsegment "B5" fracture surface.

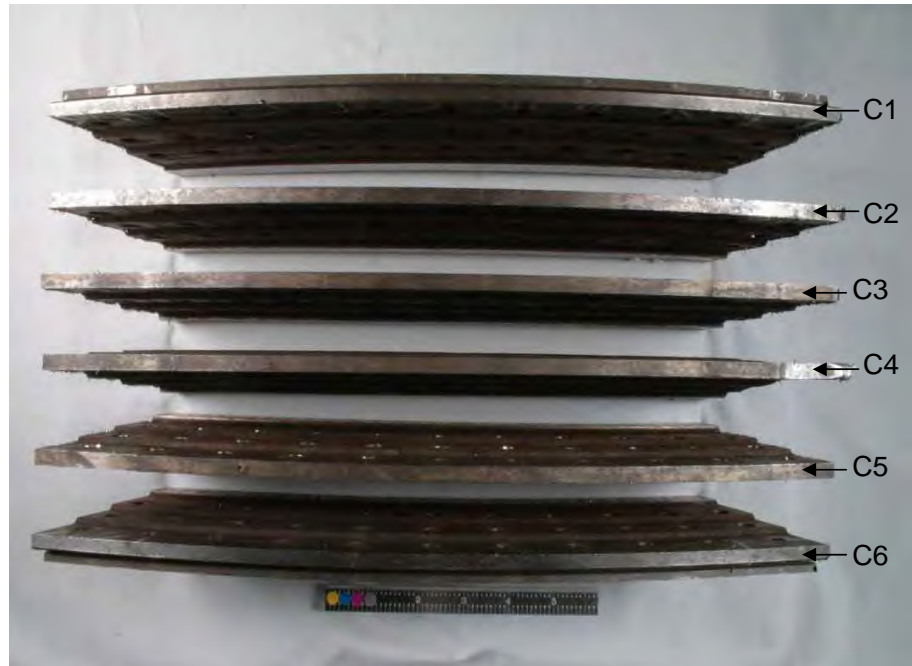
Subsegment "C" from SID 14875 was sectioned circumferentially between the finger pinned blade attachments and each finger was identified as "C1-C6" as shown in Fig. 154. No finger pinned blade attachments were fractured however, all internal fingers exhibited circumferential/radial cracks. The cracks occurred along both the inlet and outlet sides of the finger pinned blade attachments in the ledges at changes in section thickness as well as emanating from the 9:00 and 3:00 locations around the pin holes in the finger pinned blade attachments. Three representative cracks were selected for further examination as shown in Fig. 155. Close-up photographs of the three selected cracks are shown in Figs. 156 to 165. It was noted that shallow circumferential machining grooves were present on all the side faces of the finger pinned blade attachments. In some cases cracks progressed from and along the machining grooves while at other locations they did not. These machining grooves are shown in Figs. 159, 162-163 and 165. The three representative cracks were fractured open revealing coarse textured fracture morphology similar to that observed on the previously detailed fractured finger pinned blade attachments. The fractured open crack surfaces are shown in Figs. 166 to 172.

Fig. 154. SID 14875 subsegment "C" after circumferential sectioning.
