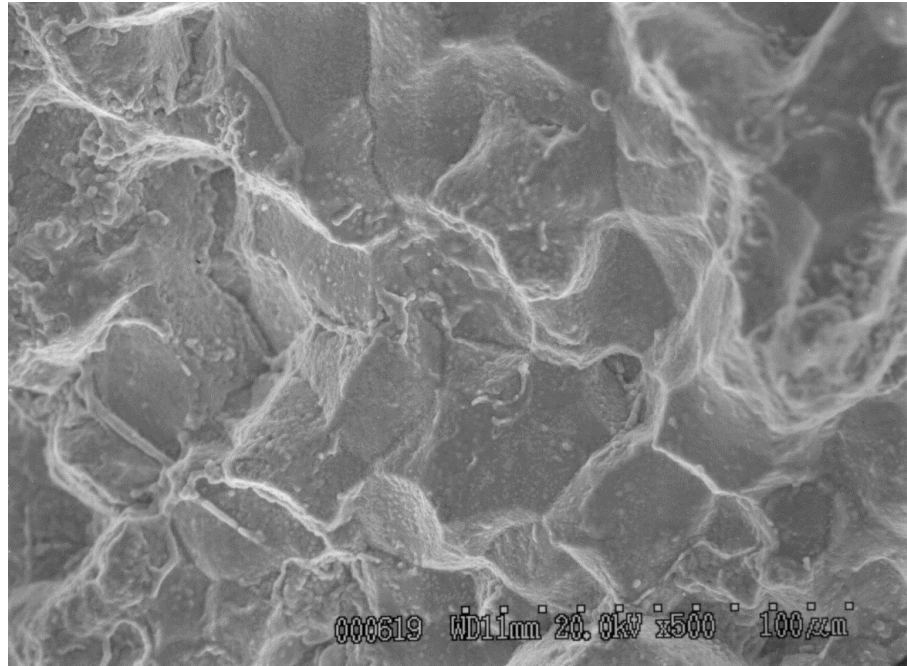
Fig. 187. Scanning electron microscope fractograph of SID 14875 "B4" Area "E".

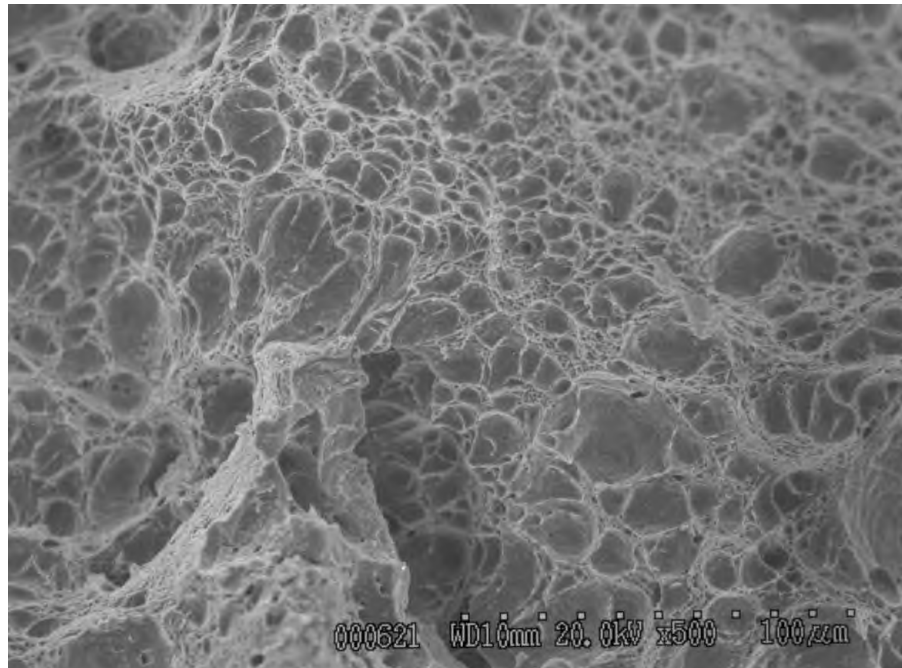
Fig. 189 Scanning electron microscope fractograph of SID 14875 "B4" Area "F".

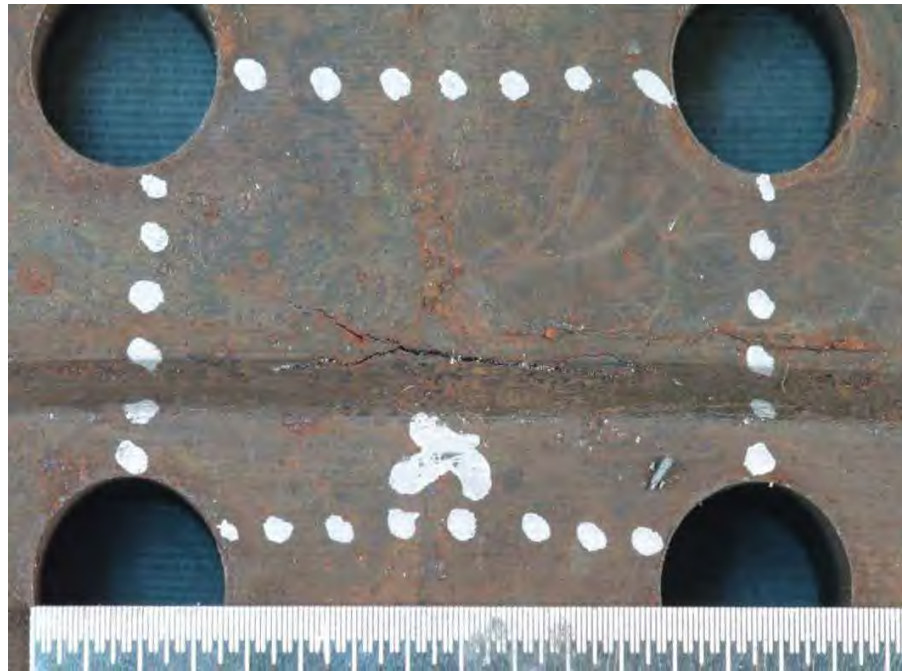
Fig. 242. Close-up of met sample L349102.

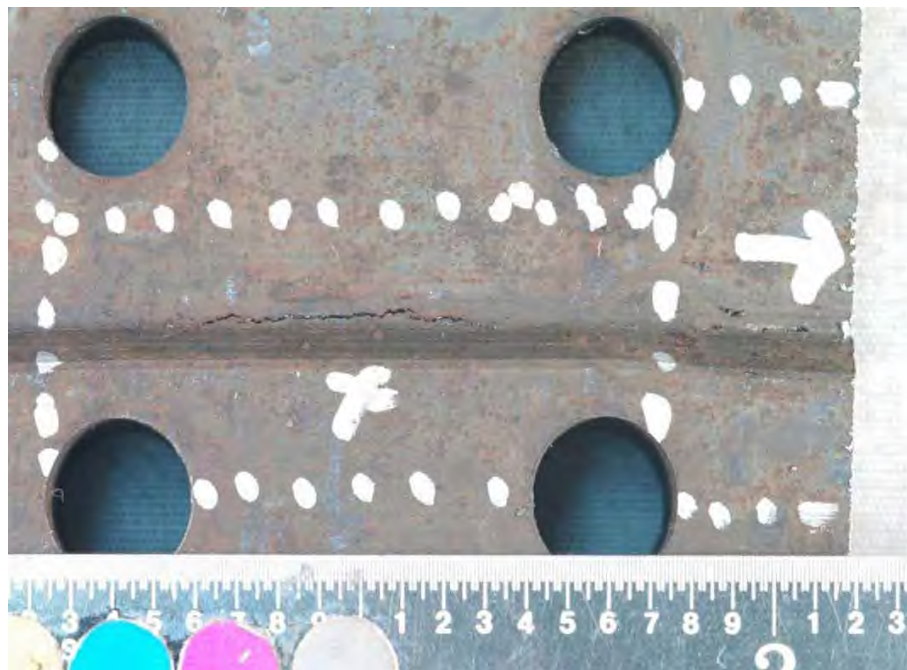
Fig. 249. Close-up of met samples L349103 and L349104.
