List of Protocols
Sherco Unit No. 3 Root Cause Analysis

**Protocol for the Removal of the Damaged Rim (L-1) from the LP-B Rotor:
Sherburne County Generating Plant Unit 3 failure November 19, 2011
Becker, MN**

TEST PROTOCOL NO. 2**FOR SHERCO NO. 3 LP ROTOR-B FAILED L-1 RIM
ENGEL METALLURGICAL PROJECT 954-001**

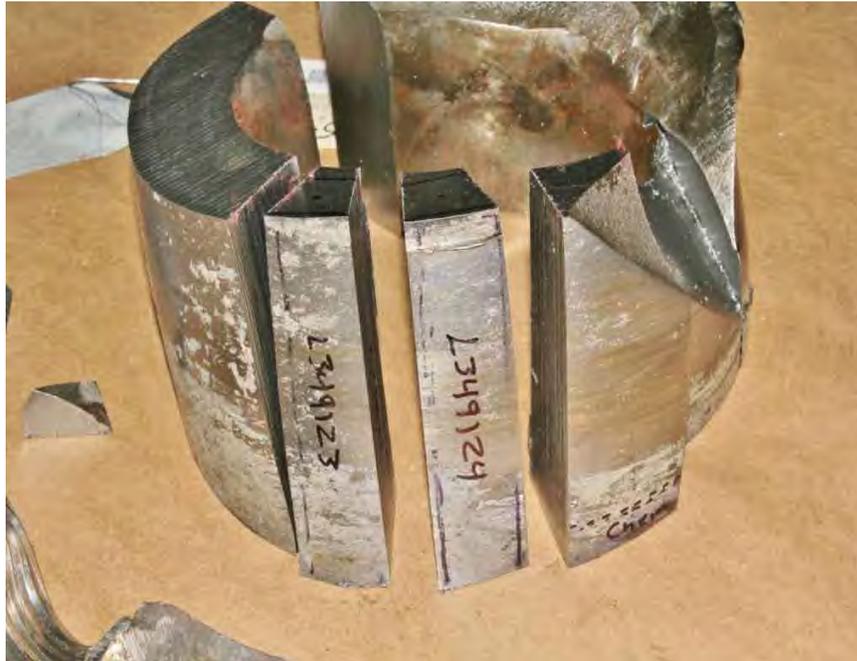
Fig. 331. Close-up photograph of generator shaft forward end fracture half showing two coupons removed for tensile specimens.

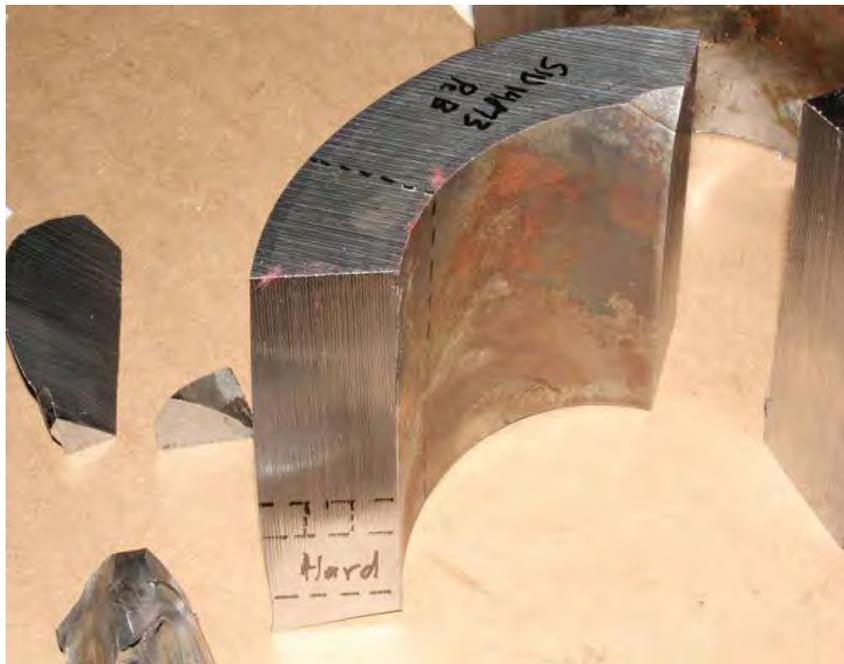
Fig. 332. Close-up photograph of generator shaft forward end fracture half showing subsegment removed for hardness testing.

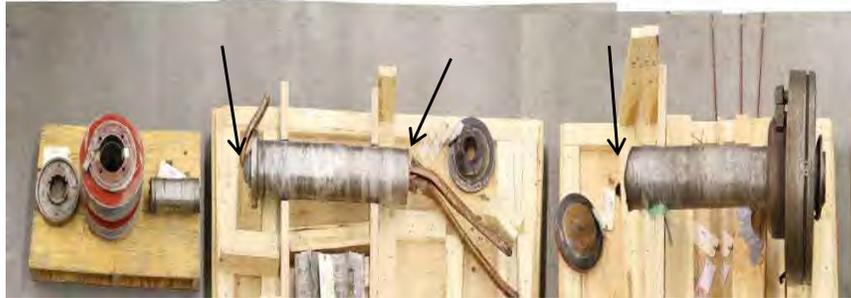
Fig. 337. Sherco Unit 3 exciter shaft that fractured transversely at three locations (arrows) during event of Nov. 19, 2011.

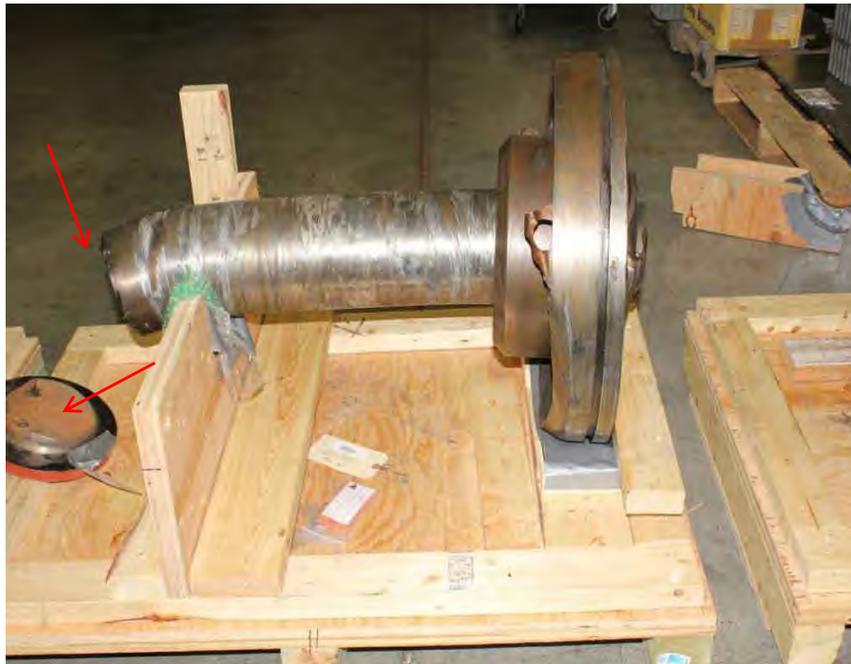
Fig. 338. Photograph of exciter shaft that fractured transversely (arrows) adjacent to the No. 11 bearing.

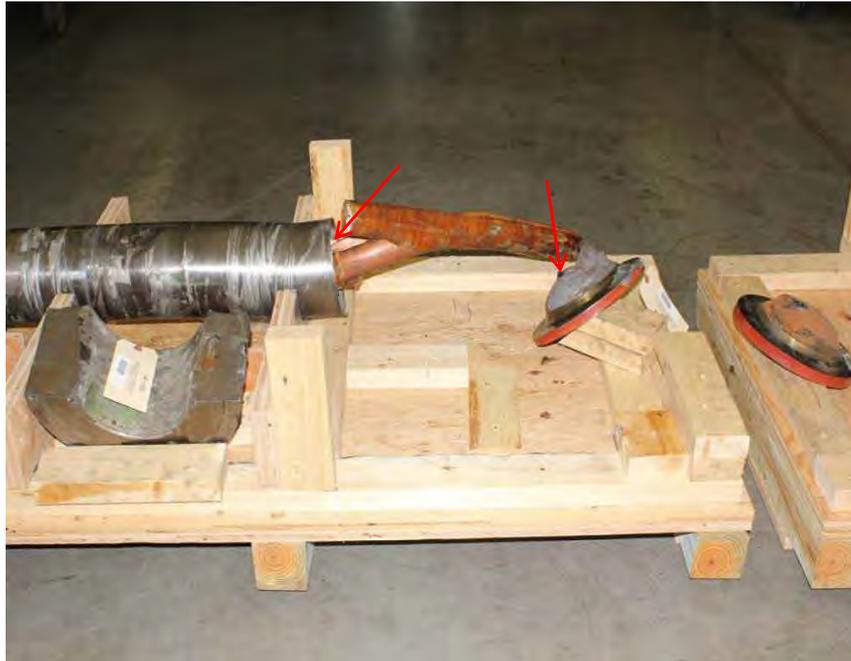
Fig. 339. Photograph of exciter shaft that fractured transversely (arrows) adjacent to the No. 12 bearing.

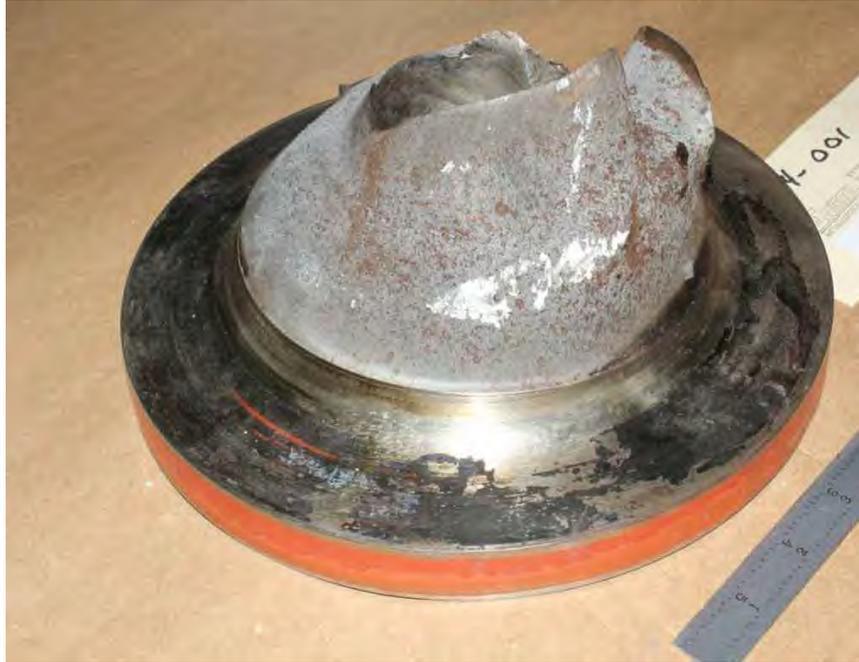
Fig. 345. Close-up of fracture surface of exciter shaft fracture adjacent to the No. 12 bearing.

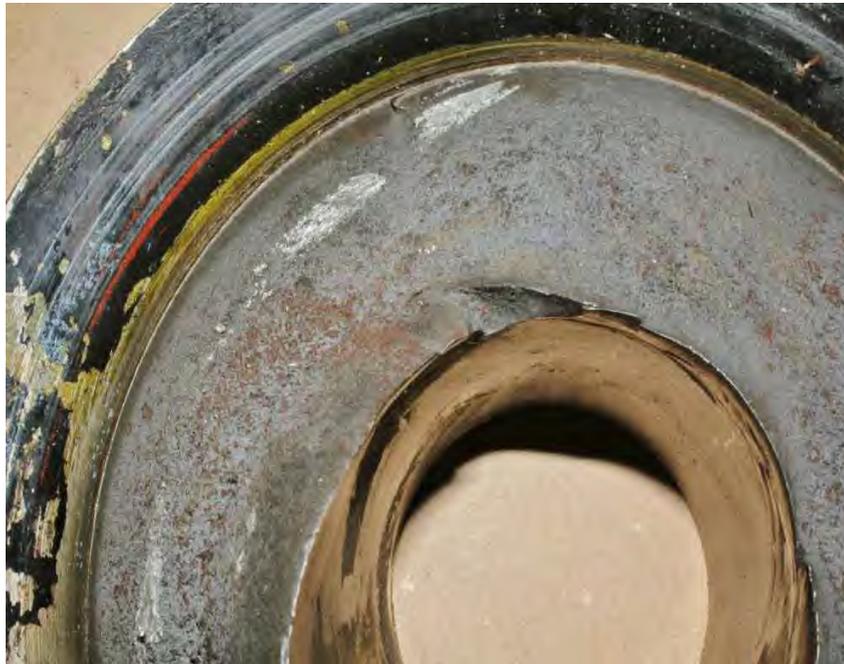
Fig. 346. Close-up of fracture surface of exciter shaft fracture adjacent to the No. 12 bearing.

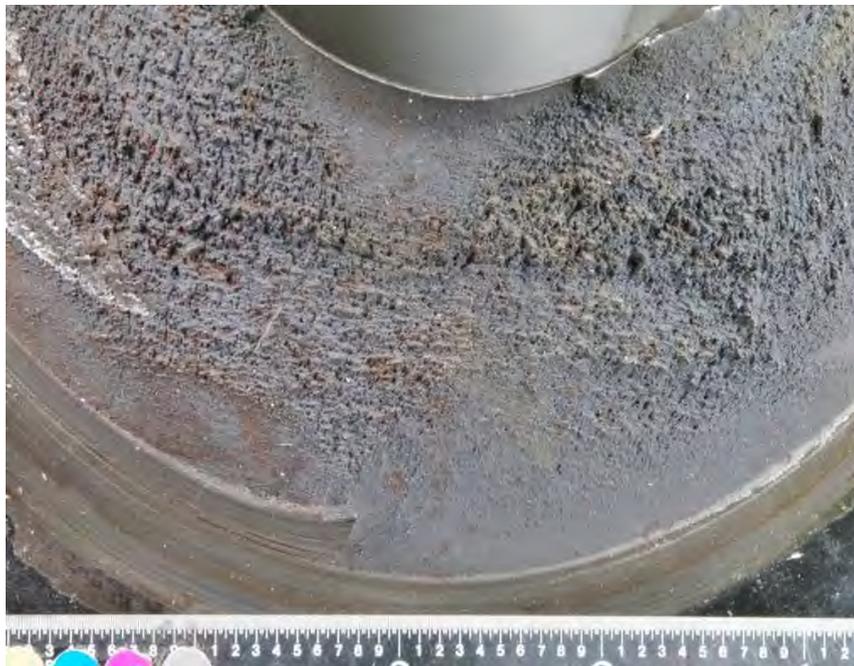
Fig. 348. Close-up of fracture surface of exciter shaft fracture adjacent to the No. 12 bearing.

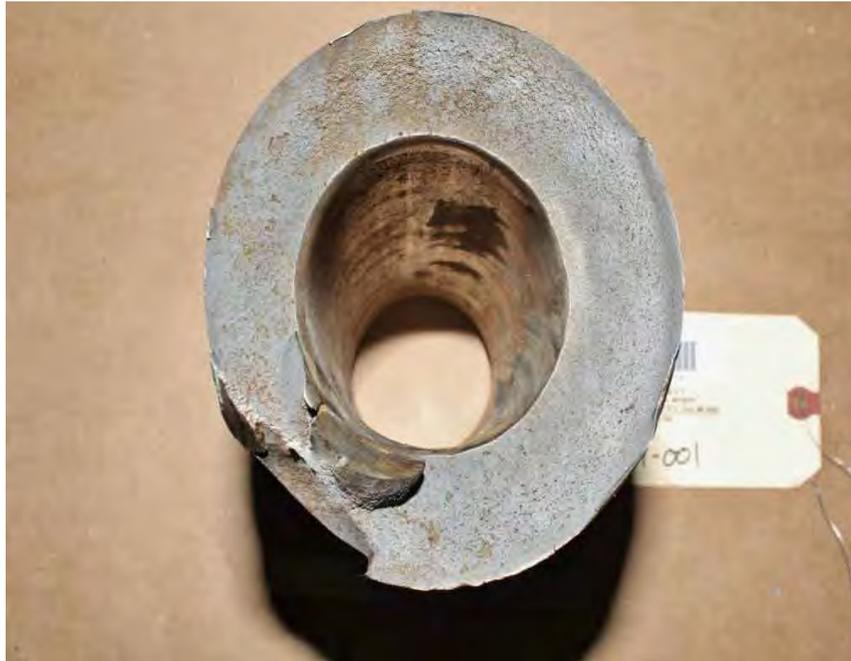
Fig. 349. Close-up of fracture surface of exciter shaft fracture adjacent to the Alterex collector ring.

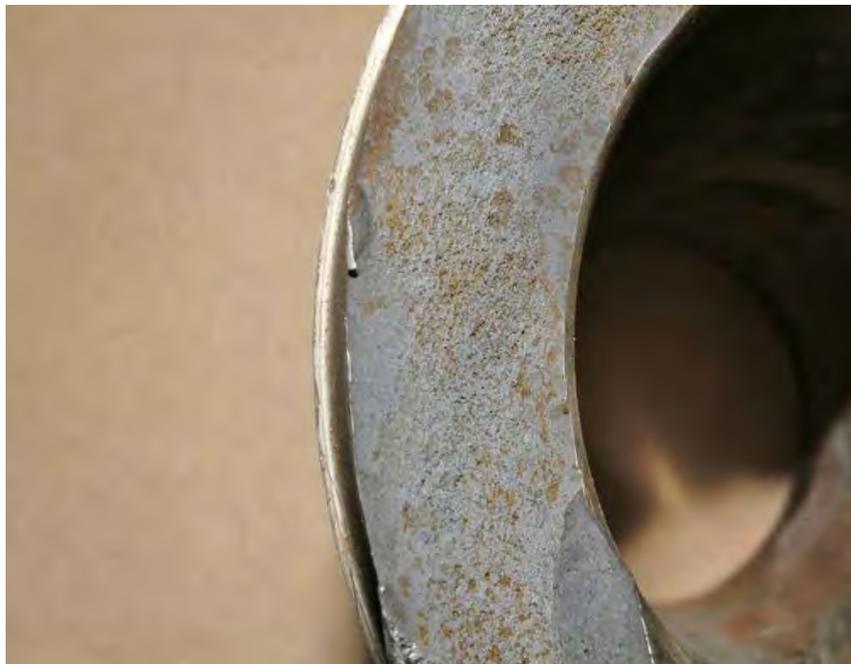
Fig. 350. Close-up of fracture surface of exciter shaft fracture adjacent to the Alterex collector ring.

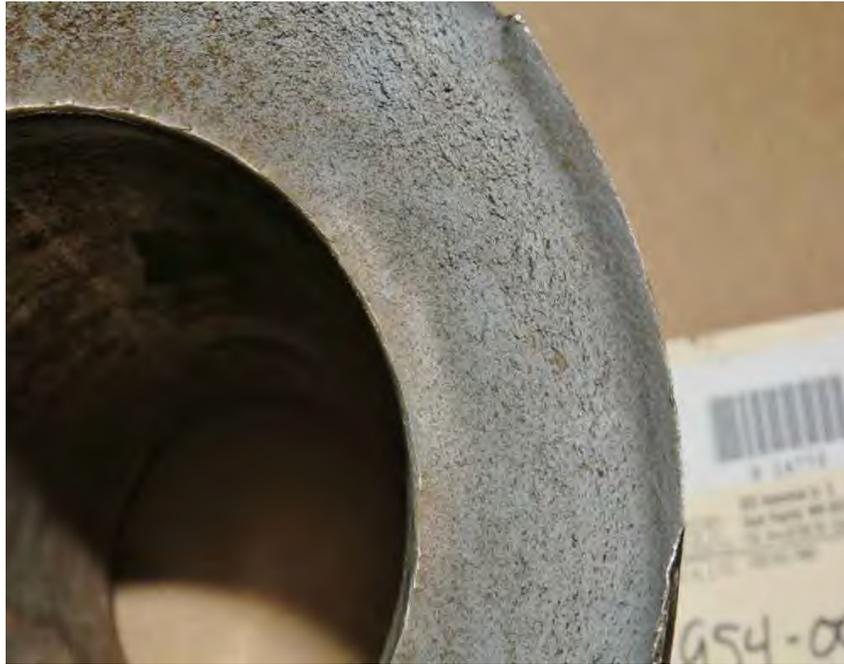
Fig. 351. Close-up of fracture surface of exciter shaft fracture adjacent to the Alterex collector ring.

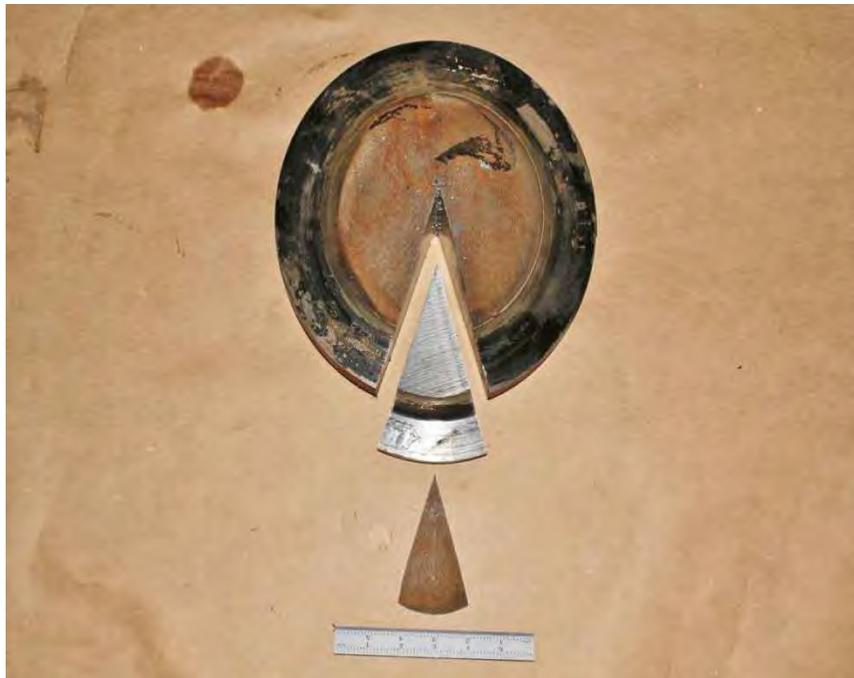
Fig 352. Photograph of exciter shaft fracture adjacent to the No. 11 bearing showing subsegment removed for scanning electron microscope examination.

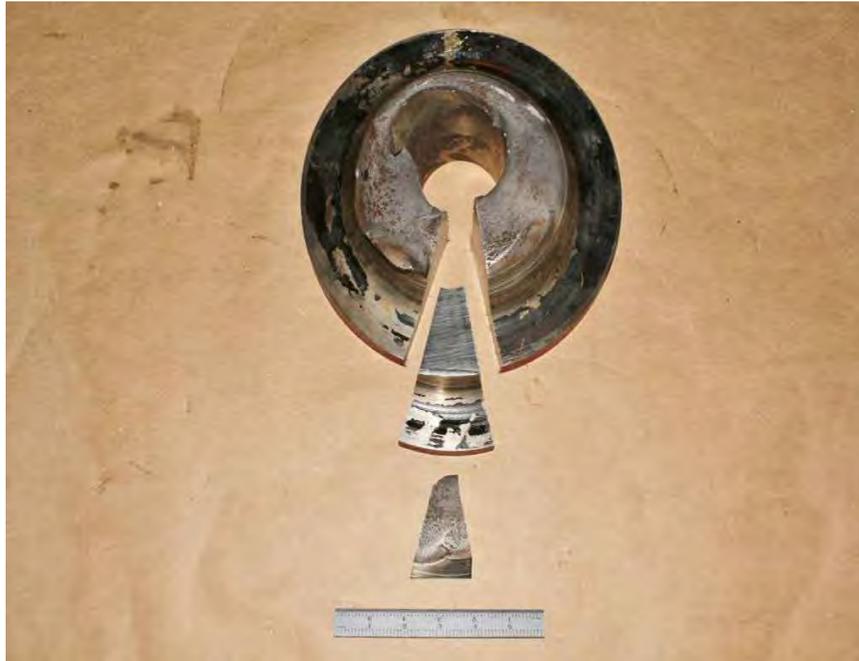
Fig. 359. Photograph of exciter shaft fracture adjacent to the No. 12 bearing showing subsegment removed for scanning electron microscope examination.

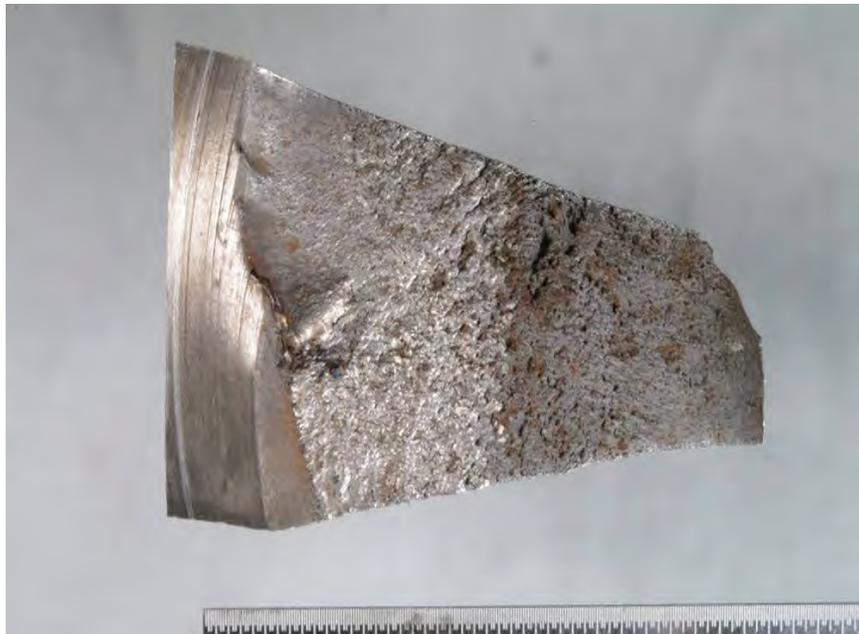
Fig. 360. Photograph of exciter shaft fracture adjacent to the No. 12 bearing showing areas examined by scanning electron microscope.

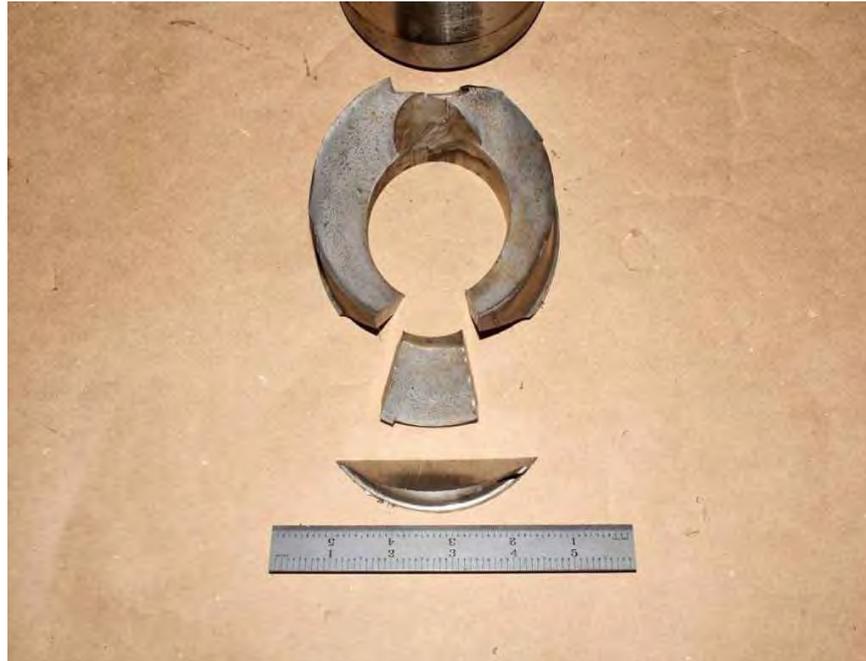
Fig. 368. Photograph of exciter shaft fracture adjacent to the Alterex collector ring showing subsegment removed for scanning electron microscope examination.

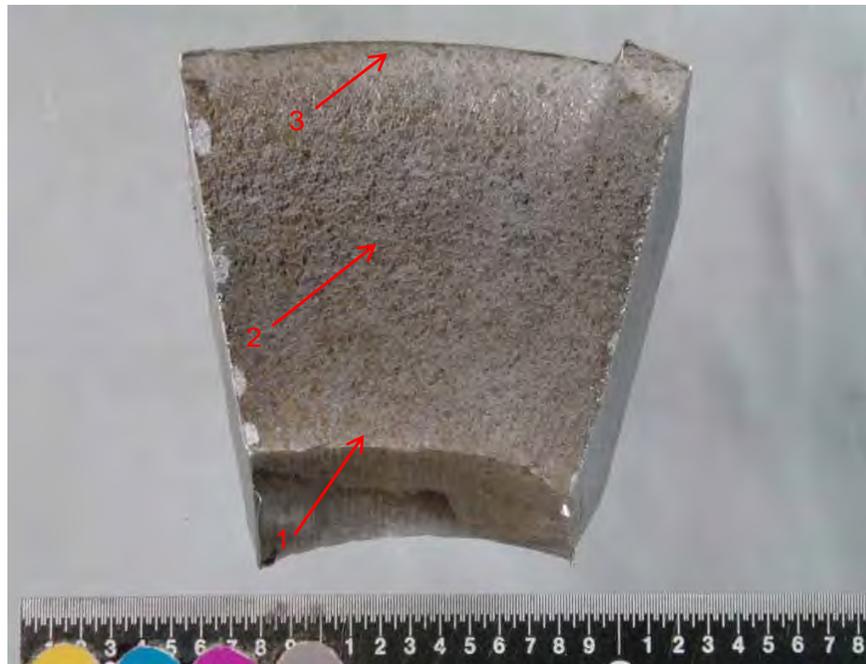
Fig. 369. Photograph of exciter shaft fracture adjacent to the Alterex collector ring showing areas examined by scanning electron microscope.

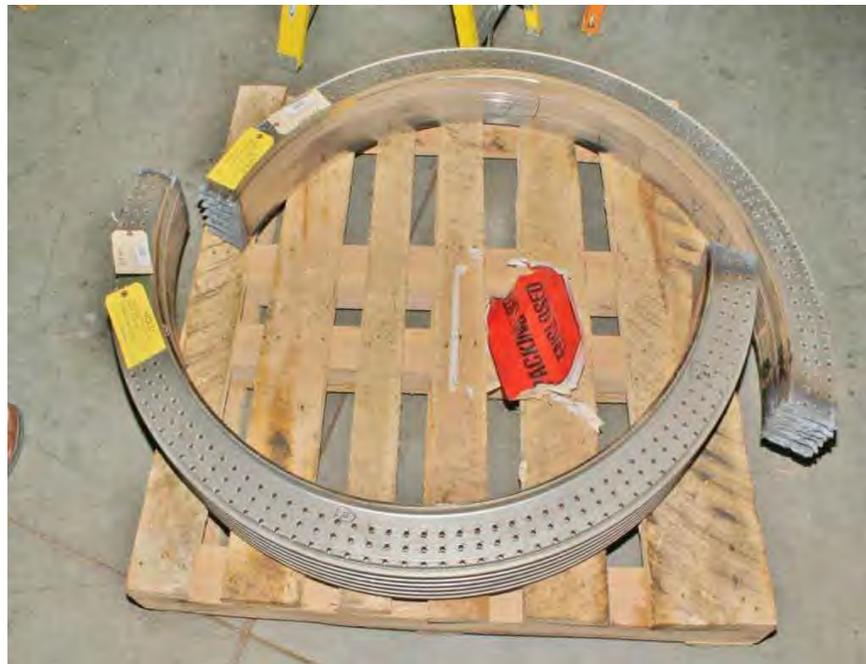
Fig. 379. Photograph of turbine end L-1 disk rim from LP turbine "A". The disk rim had been sectioned and removed at GE Repair Facility in Chicago, Illinois.

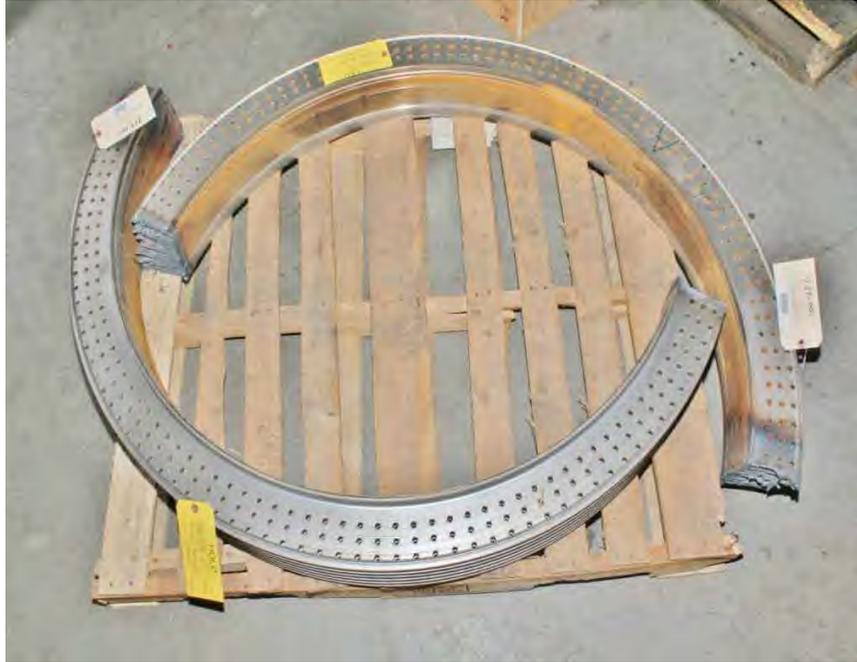
Fig. 380. Photograph of generator end L-1 disk rim from LP turbine "A". The disk rim had been sectioned and removed at GE Repair Facility in Chicago, Illinois.

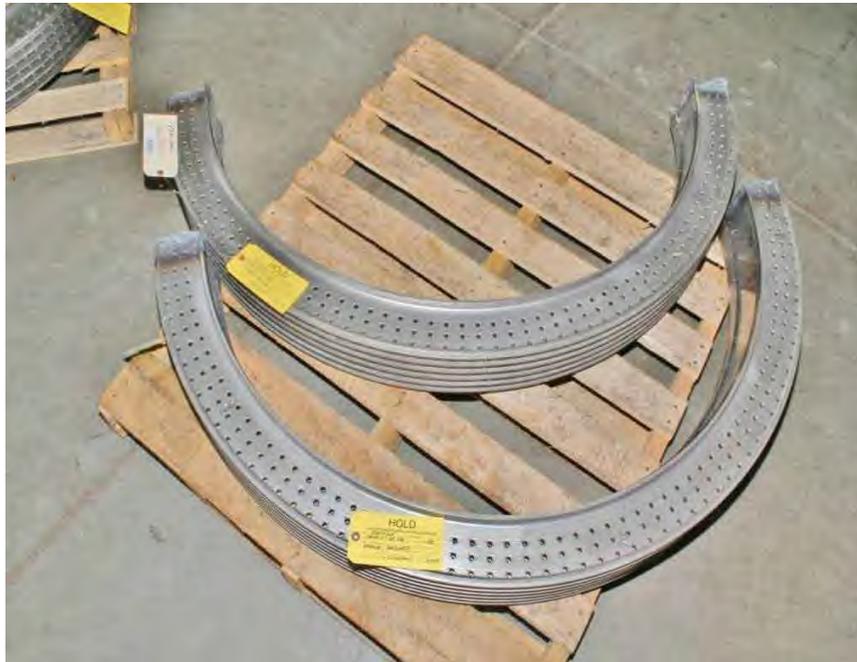
Fig. 381. Photograph of turbine end L-1 disk rim from LP turbine "A". The disk rim had been sectioned and removed at GE Repair Facility in Chicago, Illinois.

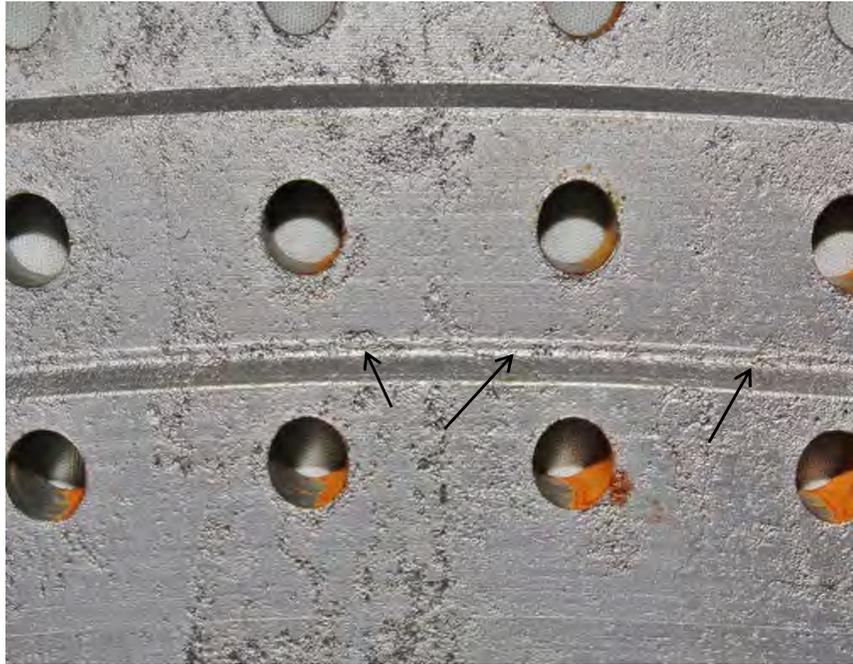
Fig. 382. Close-up photograph of turbine end L-1 finger pinned blade attachment from LP turbine "A" showing location of cracks (arrows). Pc "A2", side 2.

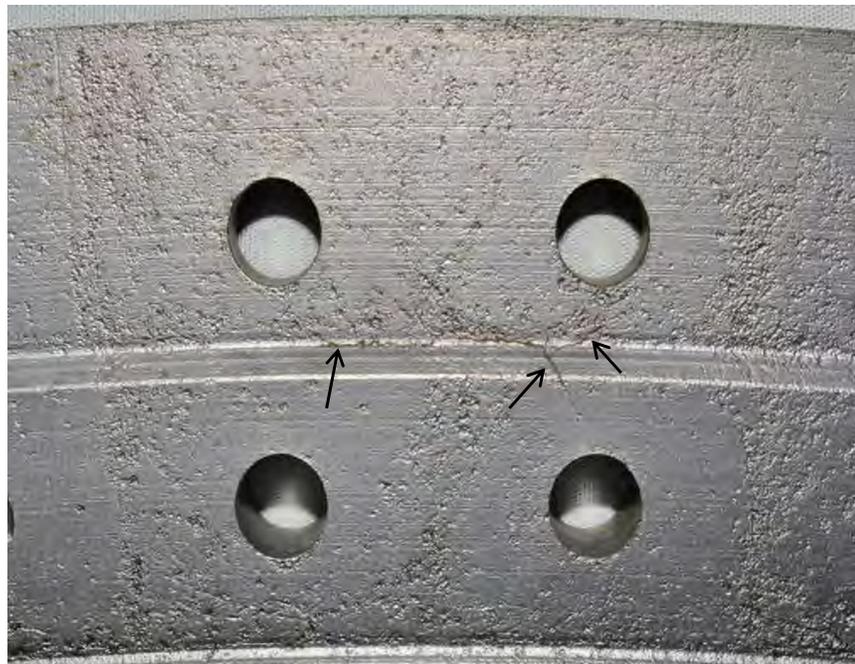
Fig. 389. Close-up photograph of generator end L-1 finger pinned blade attachment from LP turbine "A" showing location of cracks (arrows).Pc "A5", side 1.

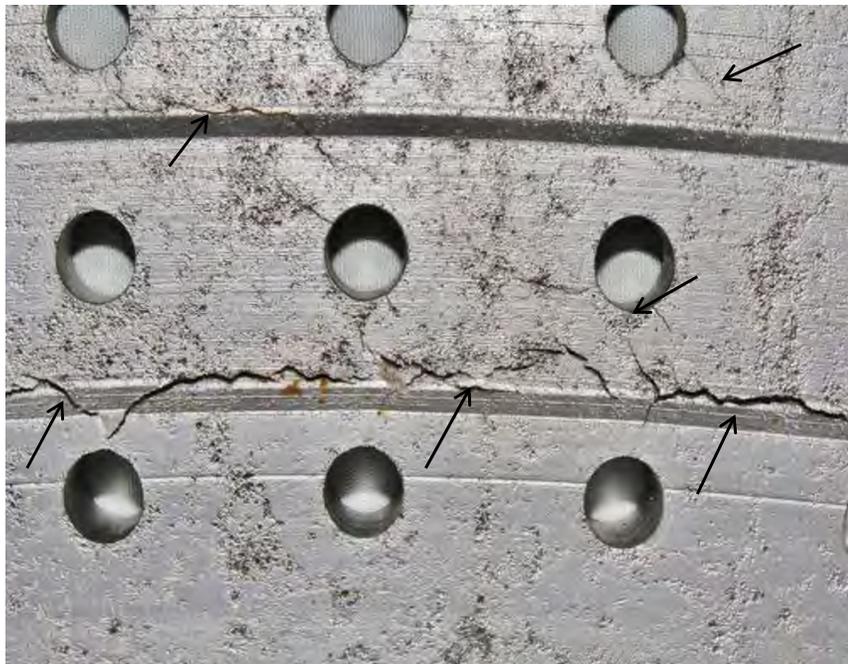
Fig. 393. Close-up photograph of generator end L-1 finger pinned blade attachment from LP turbine "B" showing location of cracks (arrows). Pc "A3", side 2.

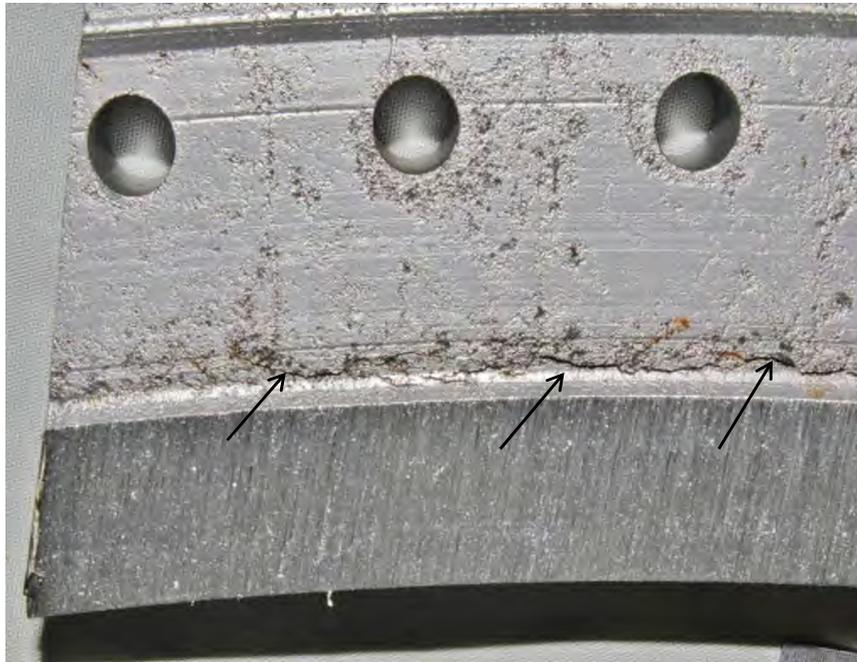
Fig 395. Close-up photograph of generator end L-1 finger pinned blade attachment from LP turbine "B" showing location of cracks (arrows). Pc "A4", side 2.

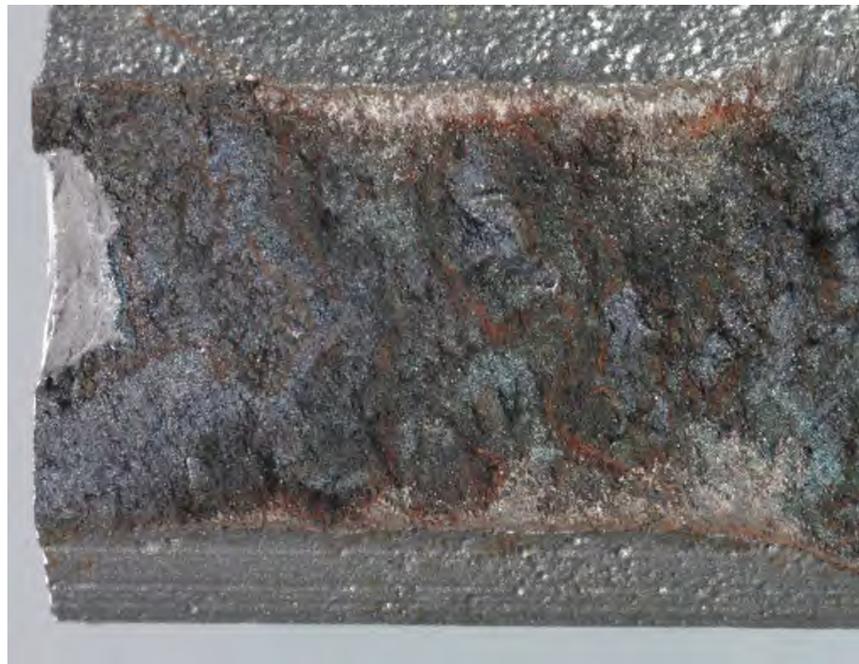
Fig. 401 Close-up photograph of crack surface from subsegment A3a shown in Fig. 398.

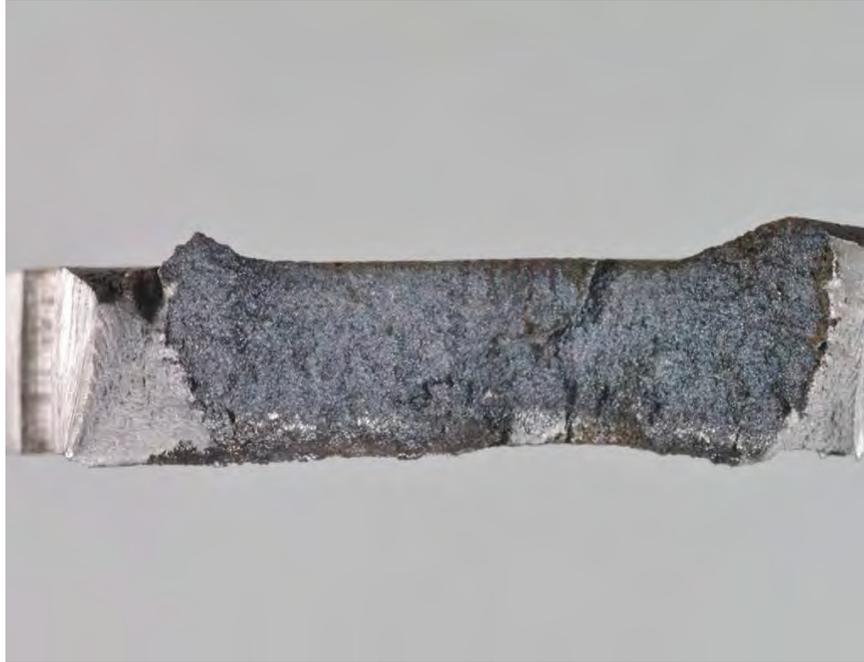
Fig. 402. Close-up photograph of crack surface from subsegment A3b shown in Fig. 399.

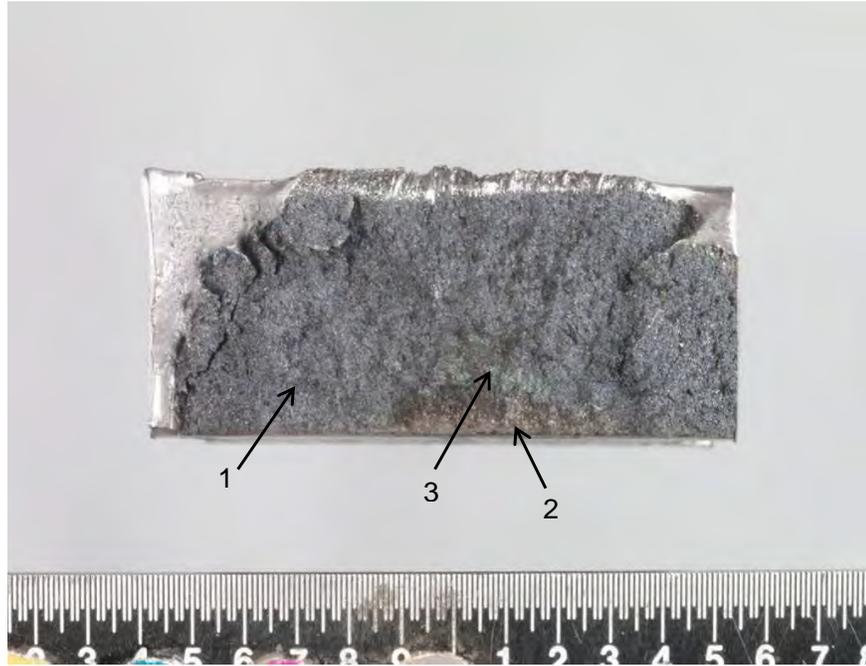
Fig. 406. Close-up photograph of crack surface from subsegment A4a shown in Fig. 404.

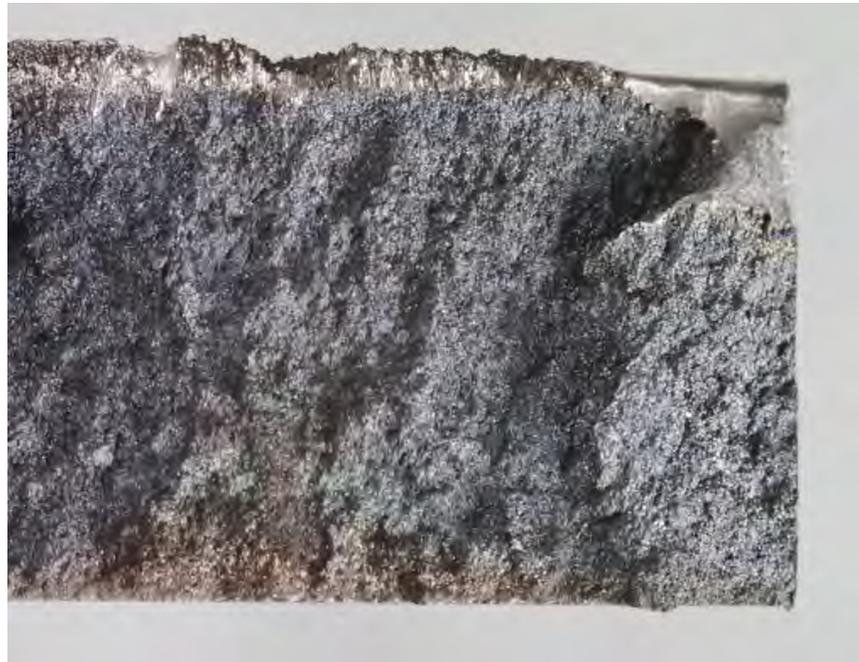
Fig. 407. Close-up photograph of crack surface from subsegment A4a shown in Fig. 404.

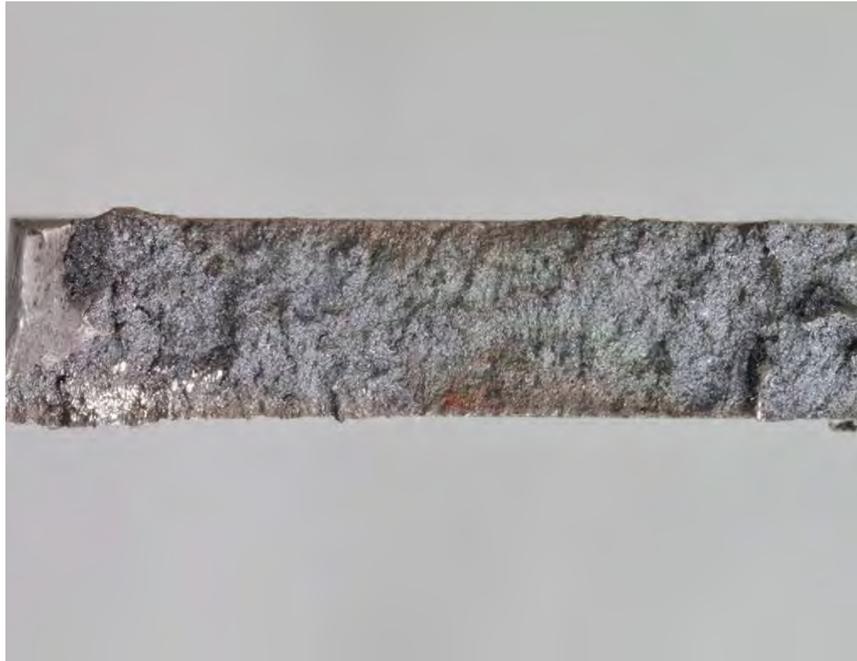
Fig. 408. Close-up photograph of crack surface from subsegment A4b shown in Fig. 405.

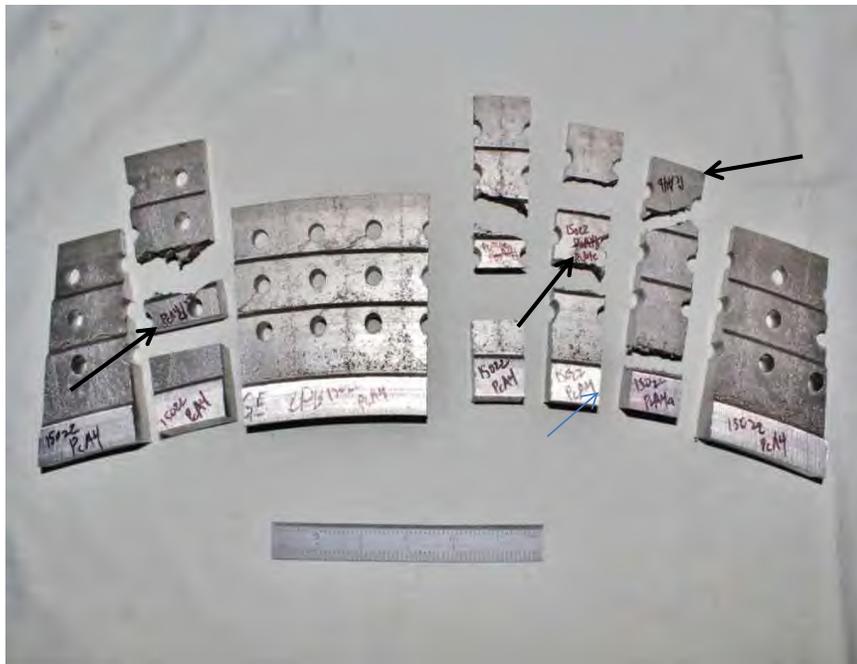
Fig. 409. Generator end finger pinned blade attachment, Pc A4, from LP turbine "B" showing sectioning of cracks (arrows) for further examination.

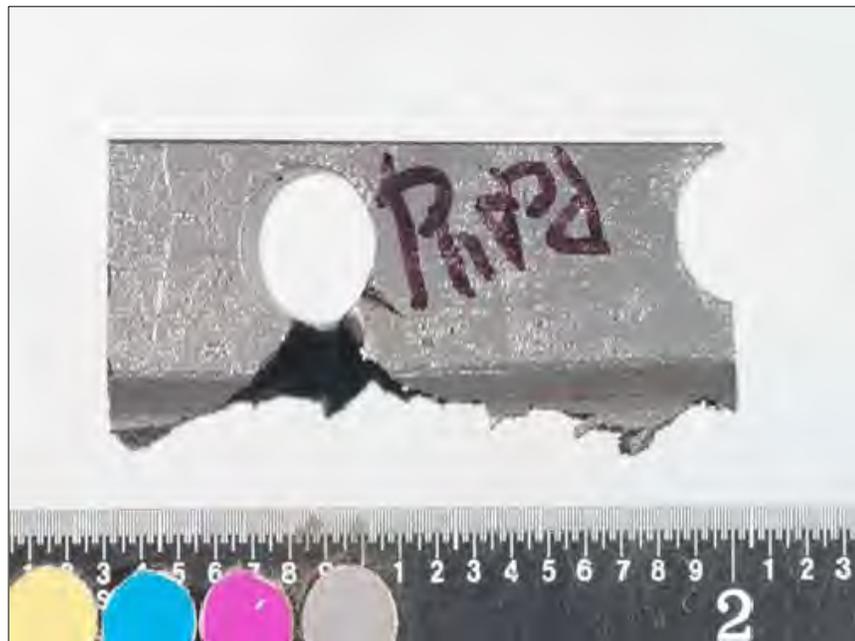
Fig. 413. Close-up photograph of subsegment A4d from LP turbine "B" containing a circumferential crack shown in Fig 409.

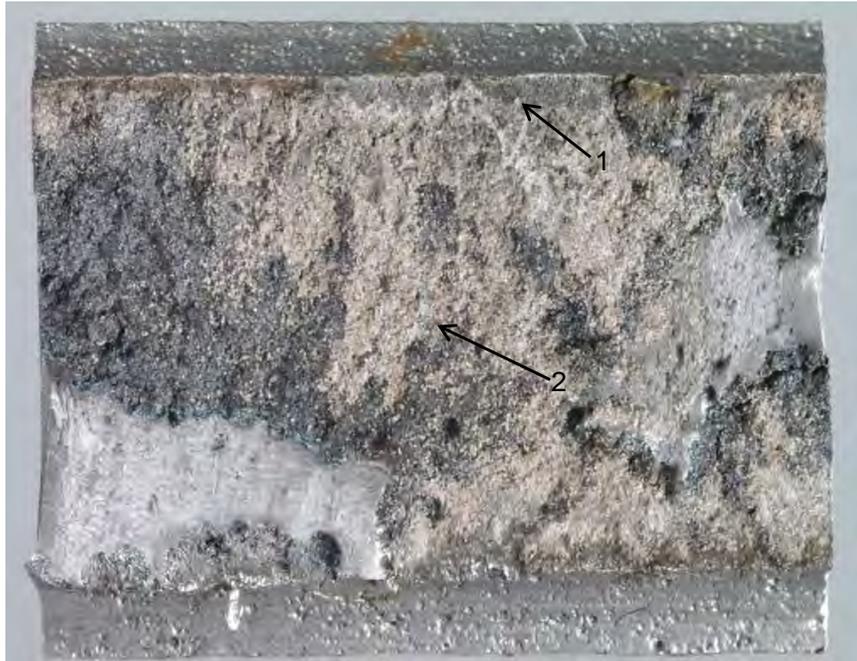
Fig. 414. Close-up photograph of crack surface from subsegment A4a shown in Fig. 410.

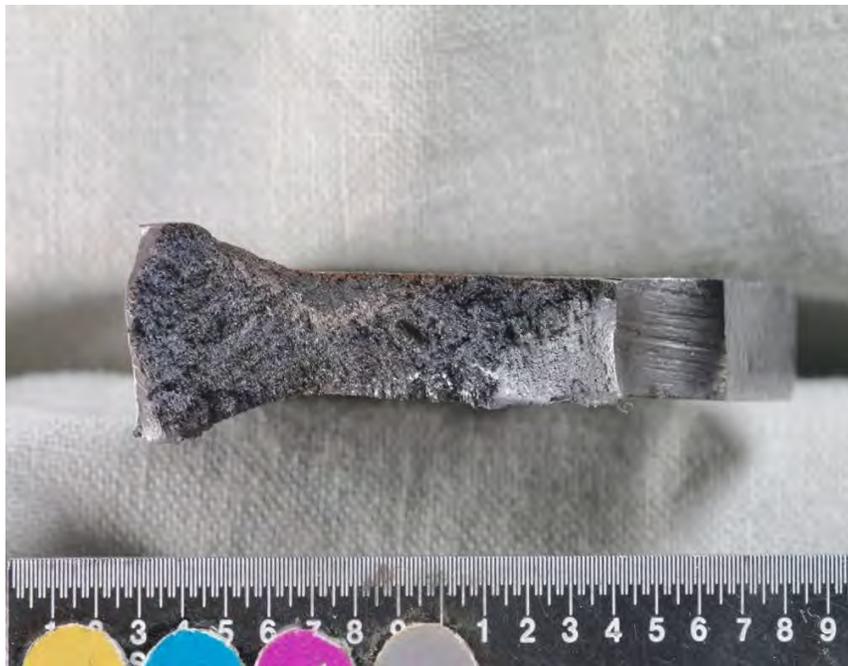
Fig. 415. Close-up photograph of crack surface from subsegment A4b shown in Fig. 411.

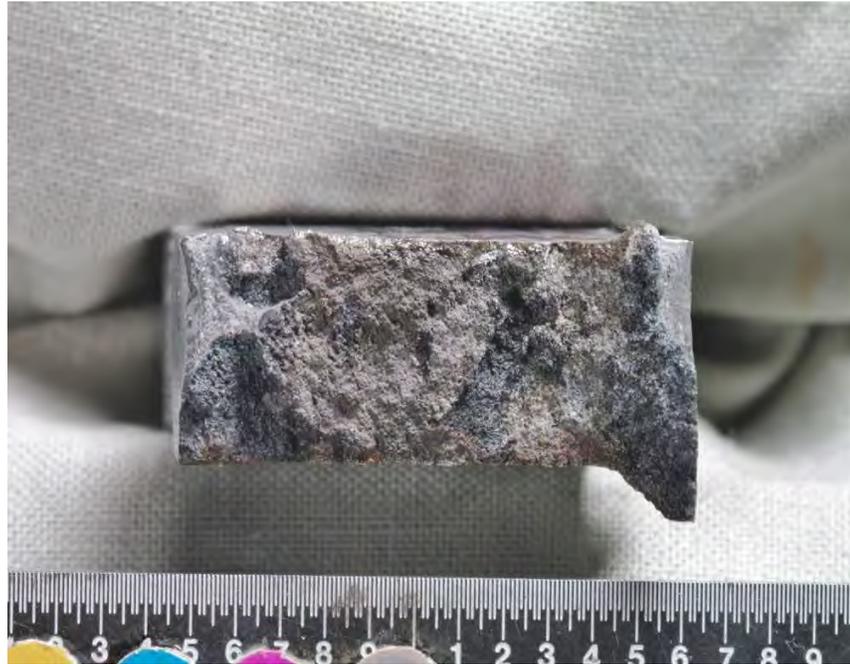
Fig. 416. Close-up photograph of crack surface from subsegment A4c shown in Fig. 412.

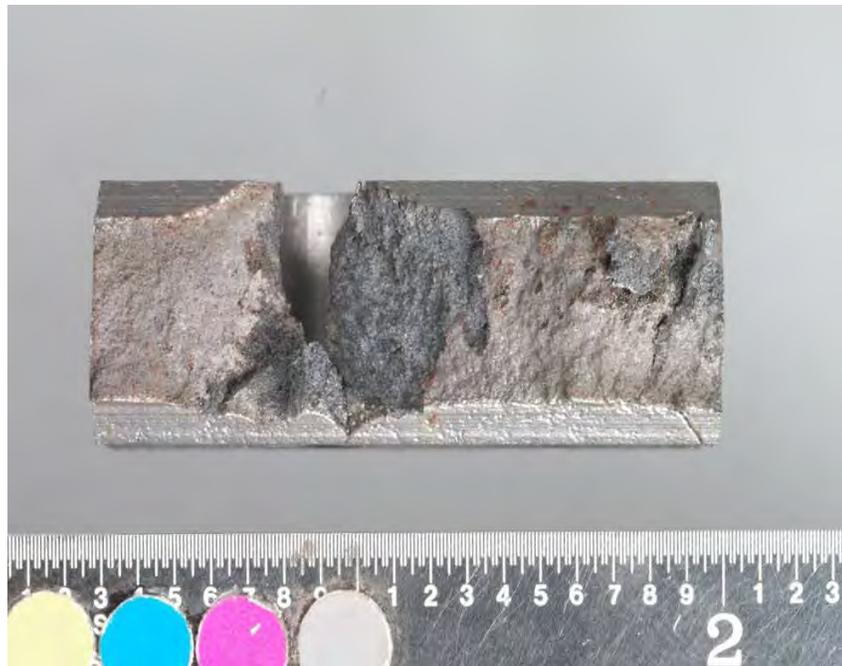
Fig. 417. Close-up photograph of crack surface from subsegment A4d shown in Fig. 413.
